**GUIDE FOR**  
**RESILIENT THERMAL**  
**ENERGY SYSTEMS DESIGN**  
**IN COLD AND ARCTIC CLIMATES**

# Guide for Resilient Thermal Energy Systems Design in Cold and Arctic Climates

January 2021

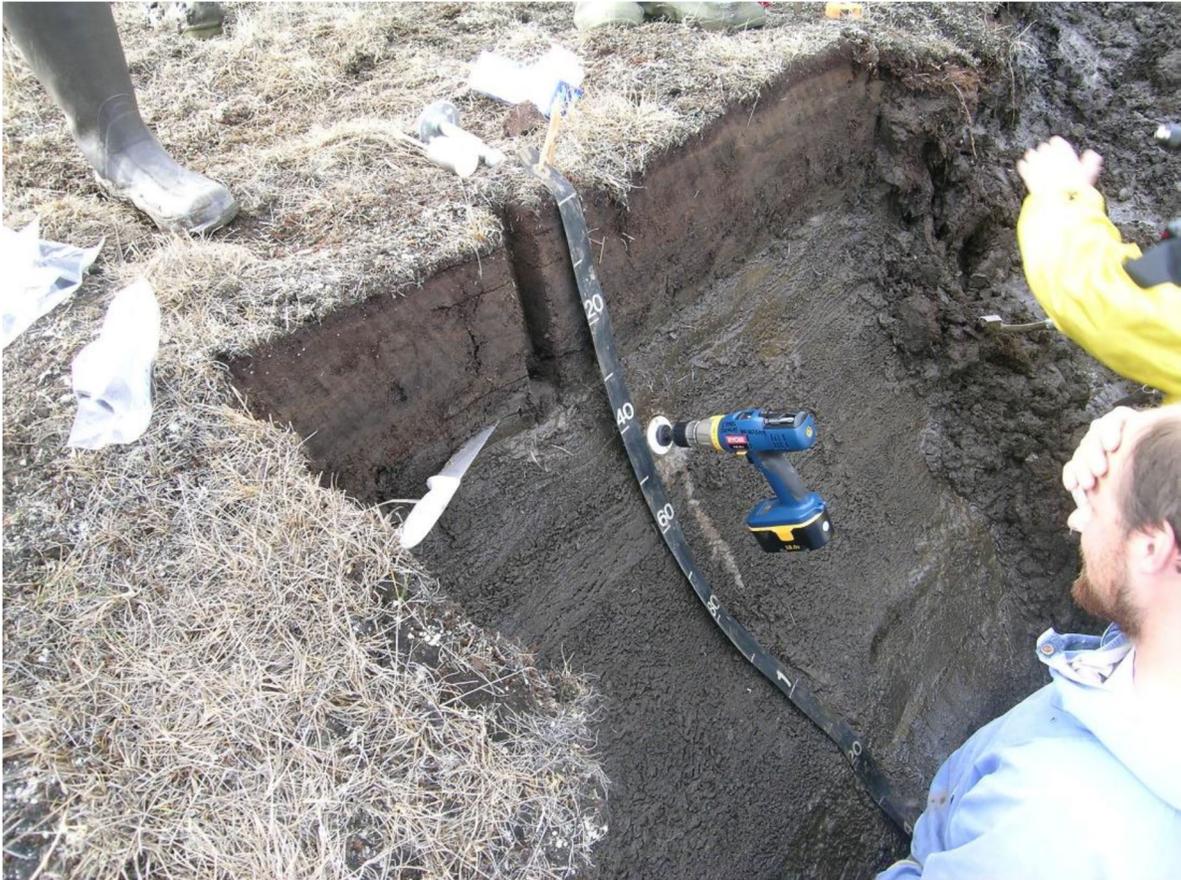
**Figure 1-4. The seasonally thawed “active layer” (dark brown surface soil) and underlying permafrost along a coastal bluff near Utqiagvik, Alaska.**

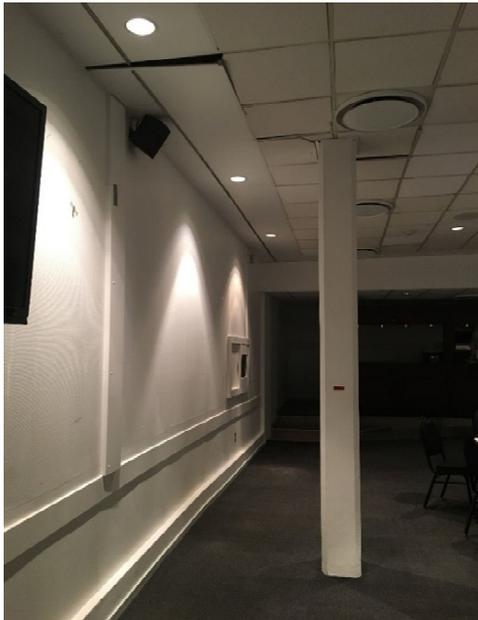
**Figure 5-2. Left: A photo of a meeting room at a site in Thule, Greenland, where differential settling has led to wall and ceiling cracking. Photo by T. Douglas, CRREL.**

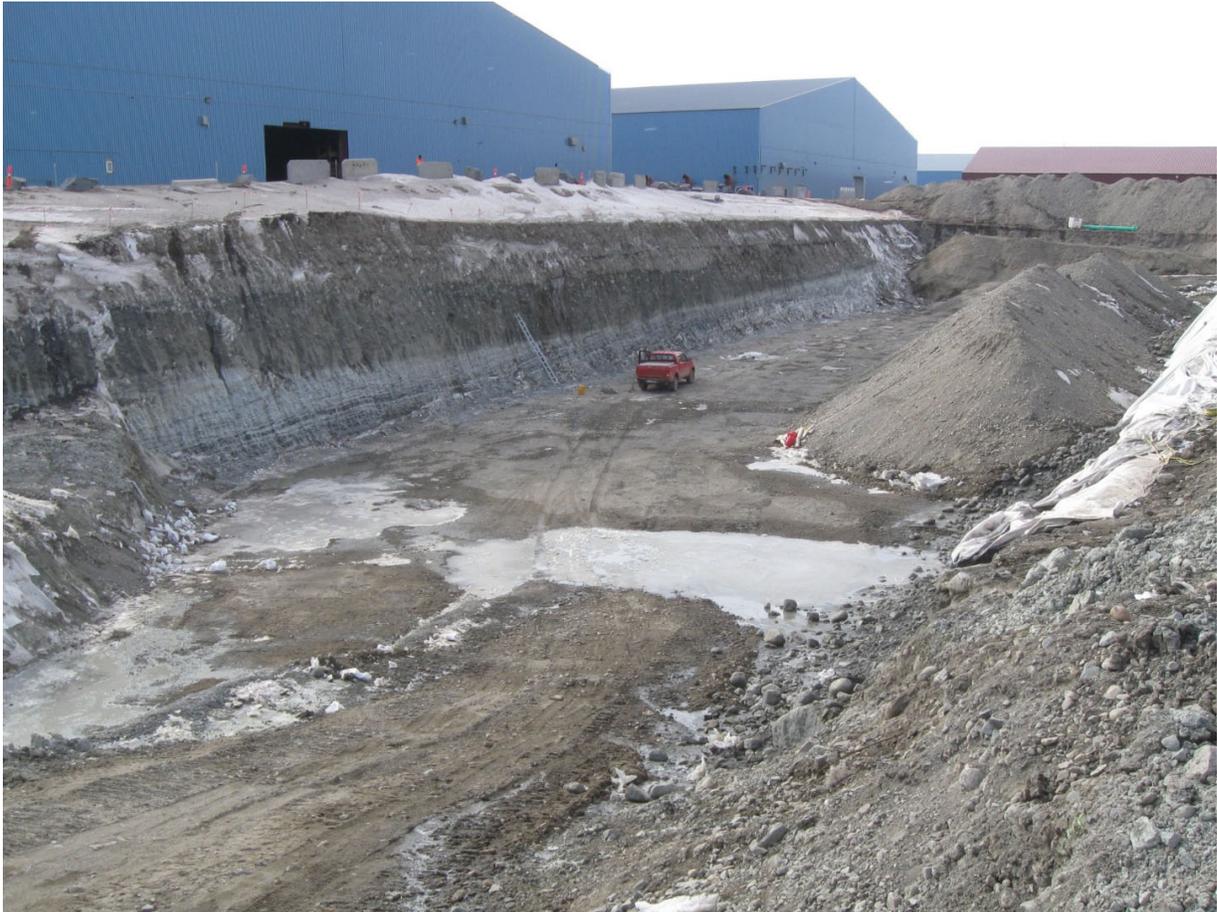
**Figure 5-4. Removal of surface ice-rich permafrost and backfilling with thaw-stable materials allows for large slab on-grade construction. Photo by K. Bjella, CRREL.**

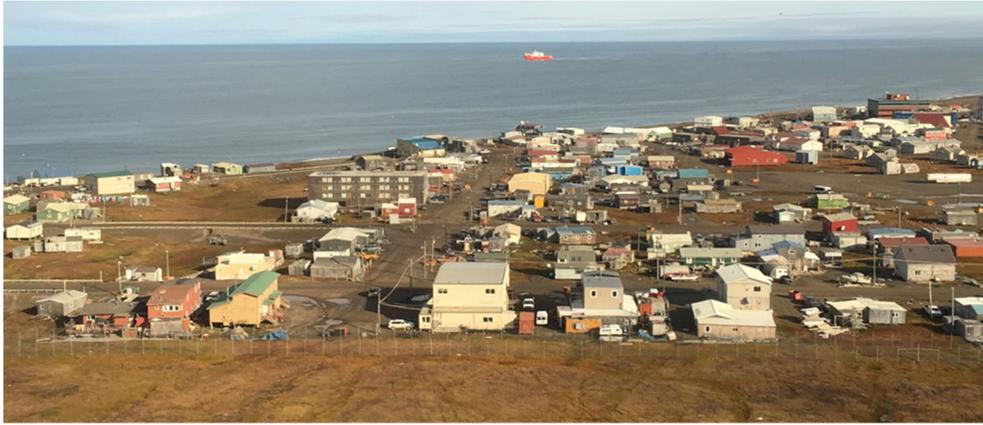
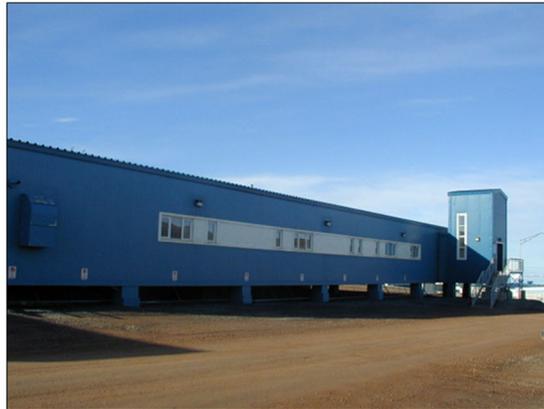
**Figure 5-5. Examples of elevated structures on permafrost. Upper photo: An image of downtown Utqiagvik, Alaska where single-story and multi-story buildings, as well as all utilidors, are constructed above ground. Lower left: a large facility at Prudhoe Bay, Alaska. Lower right: a single-story structure at Thule, Greenland. Photos by Kevin Bjella, CRREL.**

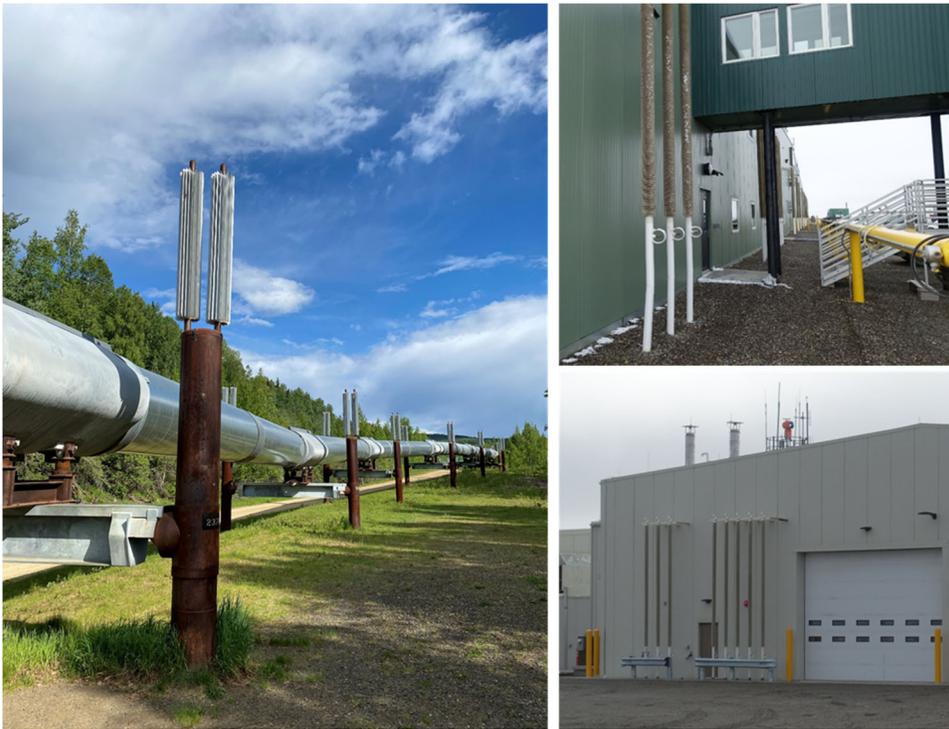
**Figure 5-7. Images of thermosyphon installations. Left: on the Trans-Alaska Pipeline near Fairbanks, Alaska. Upper and lower right: along foundation edges of structures in Prudhoe Bay, Alaska. Images by T. Douglas, CRREL.**

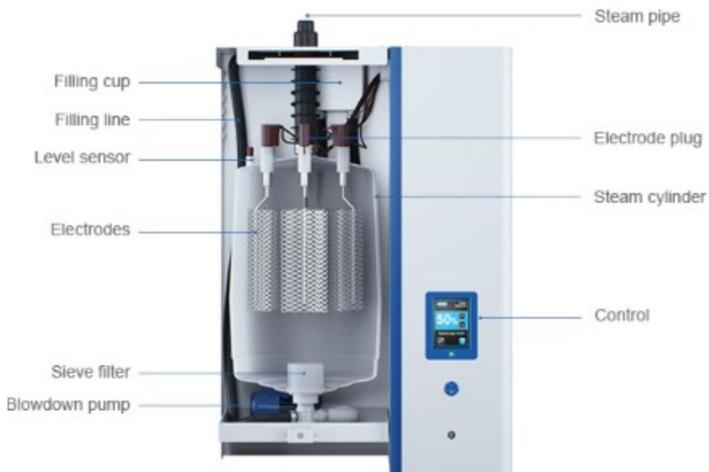
**Figure 6-4. Electrode humidifier ([www.condairgroup.com/know-how/electrode-steam-humidifier](http://www.condairgroup.com/know-how/electrode-steam-humidifier)).**

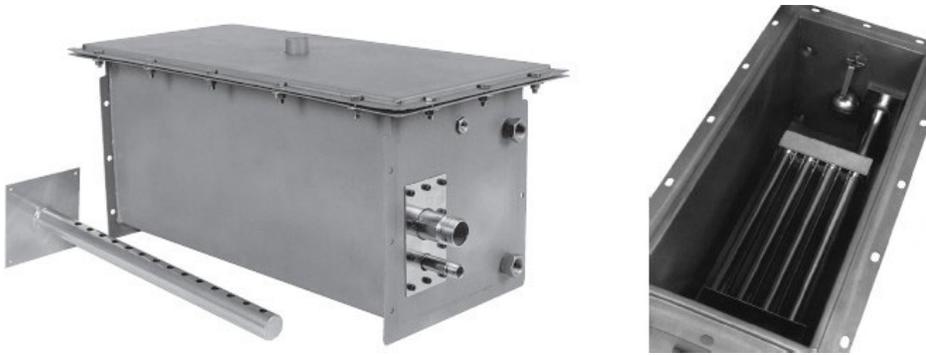
**Figure 6-5. Steam-to-steam humidifier.**

Using steam from a district steam source or steam boiler directly is not recommended due to the contaminants and treatments added. An alternative is to use a steam-to-steam humidifier (Figure 6-5) that takes source steam and uses it to generate clean steam, which is used as the humidification medium.

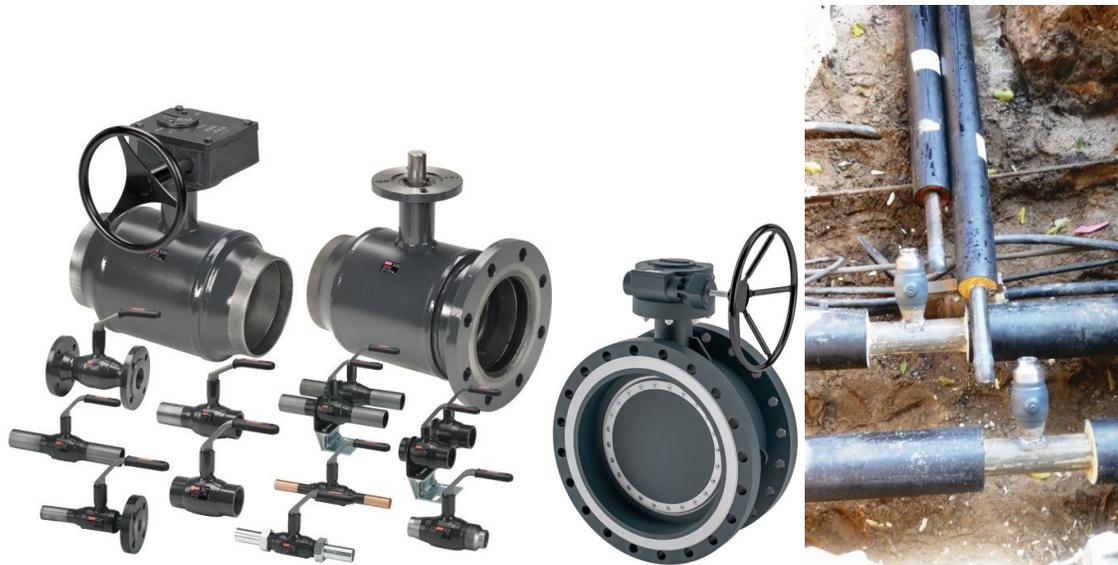
**Figure 7-6. Left: Example of ball valves in various sizes. Middle: Butterfly valve. Right: Shutoff valves installed in a pipeline. Source: Danfoss A/S.**

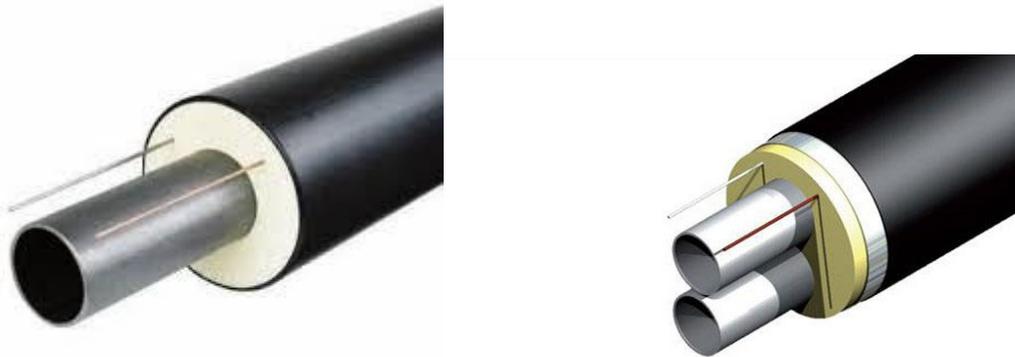
**Figure 7-7. Leakage detection wires in a pre-insulated single and twin pipe. Source: Løgstør A/S.**

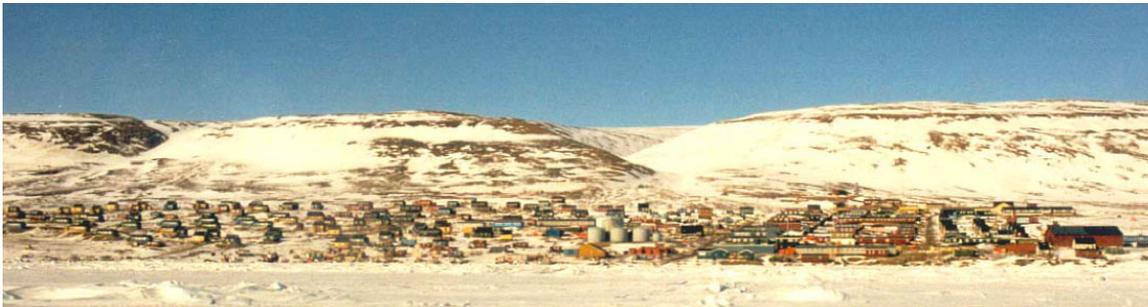
**Figure 7-12. The urban settlement in Quaanaaq, Greenland. Source: Ramboll A/S.**

The importance of resilience depends on locations and function of each site. In remote arctic regions, disconnected from electric and gas grids and devoid of local resources, the challenge of resilient solutions and efficient use of resources and opportunities is obvious. This is the case in Quaanaaq, the home to 656 people and the U.S. Thule Air Base (Figure 7-12).

The key technology to fulfill resilience requirements of the main infrastructure of Quaanaaq is the district heating system. The district heating system uses the waste heat from the three diesel power generators, which provide 1,436 kW power and 2.5 MW thermal capacity at normal operating conditions. Additionally, there are three peak load heat only boilers with capacity of 1.5 MW and two emergency power generators of 600 kW. The annual heat and power demands are 5,230 MWh and 2,750 MWh, respectively. The combined heating and power system has a fuel efficiency of 80-85% (low calorific value [LCV]) as end-use measured per fuel consumption. In case of power only generation and building heat only boilers, the combined efficiency would be only 55%.

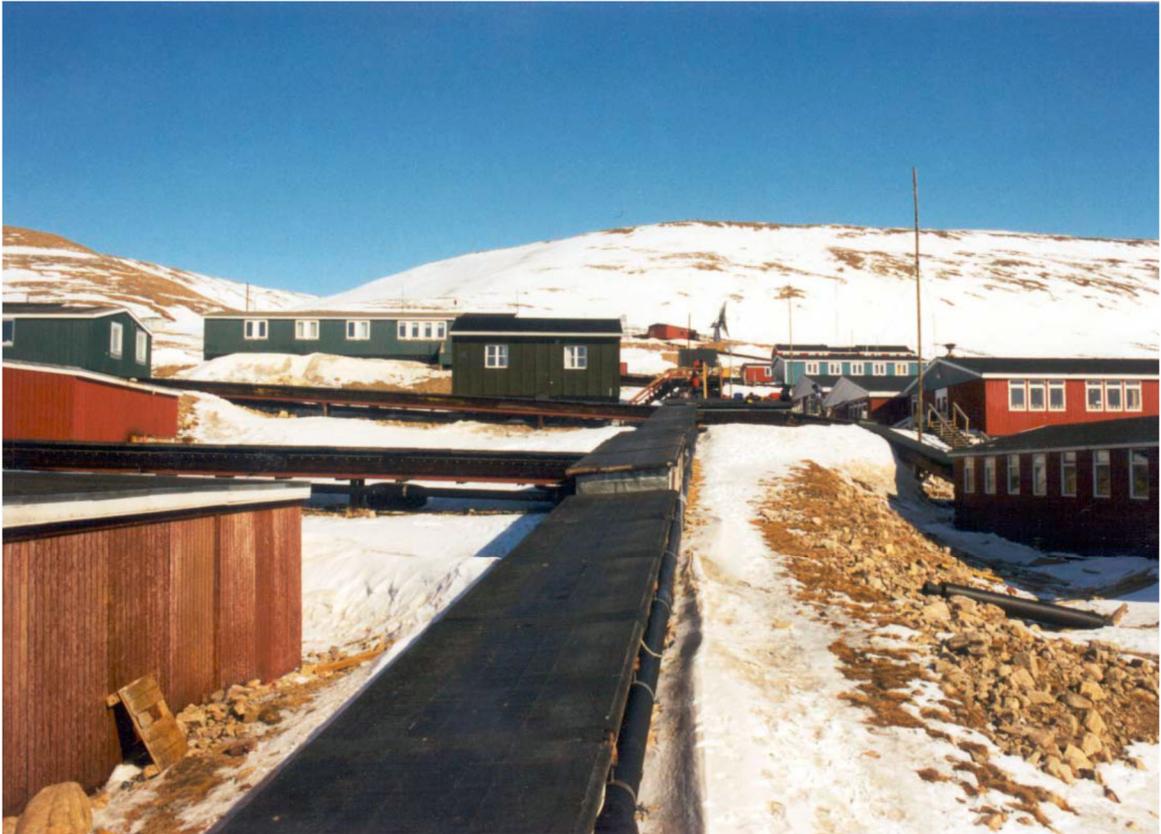
**Figure 7-13. Above-ground supply infrastructure. Source: Ramboll A/S.**

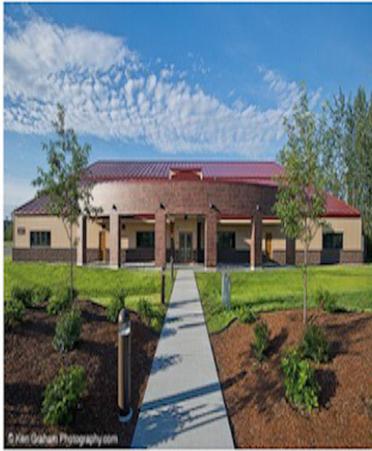
Image 6-1. Building 10 IMP Wall and Roof

**Figure A-6. The tightest building examples; Bldg. 10 digital and IR imagery.**

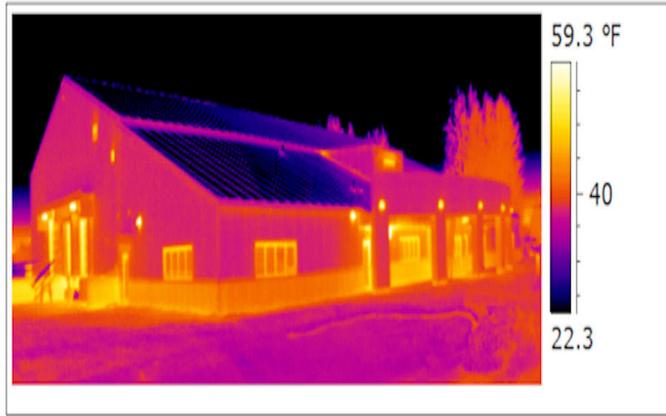
Image 6-2. Building 10 Panoramic IR Image @+25pa

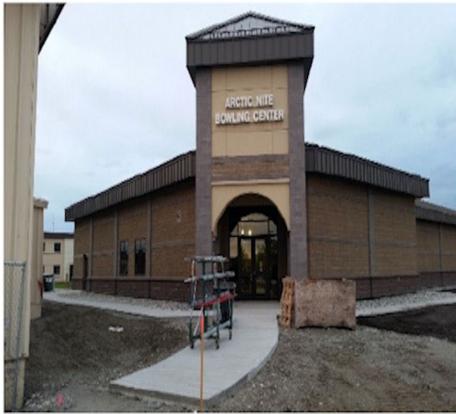
Image 7-1. Building 23 CMU Wall & Attic Ceiling

Bldg. 23 air leakage tested at 0.082cfm/ft<sup>2</sup> @75Pa. The CMU wall system had very few windows and doors because of its use as a bowling center. This project also has an attic space with metal trusses. Air barrier design review and air barrier inspections played an important role in identifying a gap at the CMU wall-to-ceiling joint and an interior wall partition top plate. Air barrier inspections identified air leakage pathways around HVAC low-leakage dampers and other air leakage pathways during construction as well. These types of quality controls have had a positive impact on projects where air barrier performance is tested. While this project far surpassed the airtightness requirement, opportunities still existed for air sealing and thermal barrier improvements. Figure A-7 shows examples of remaining air leakage and overall thermal signatures of the CMU wall system.

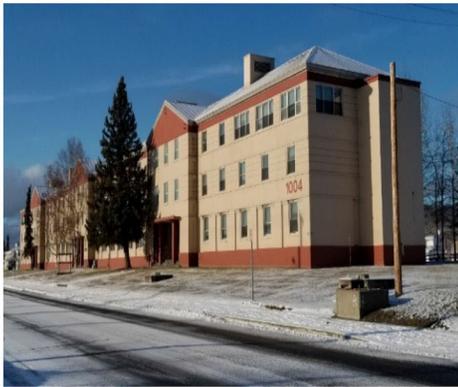
Image 8-1. Building 2 Concrete Wall/Steel Roof

Bldg. 2, had an air leakage result of 0.328cfm/ft<sup>2</sup> @75Pa. The building has single-pane, double hung aluminum windows that have significant air leakage. The roof is steel with polyurethane and fire coating, but even this had air leakage at pinholes, expansion joints, and CMU fire break walls in the hot attic. This barracks building, which now sits vacant after 70 years of service, needs either renovations or demolition. Air leakage was found at the roof-to-CMU rake walls,

structural beams, roof eaves-to-wall joints, roof peaks, windows, doors, and HVAC terminations inside cupolas. Moisture signs are typical in this building wherever air leakage is found due to the extreme climate zone, the building's age, and its high occupancy. Mold conditions were evident at locations such as expansion joints where significant air leakage pathways were found, and continuous wetting occurred for up to 9 months out of a year from condensation.

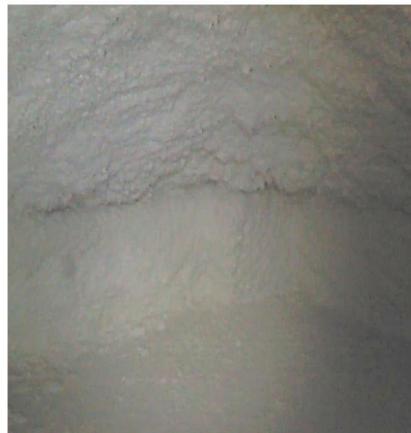
Image 8-4. Building 2 Roof to Wall Joint Dig.

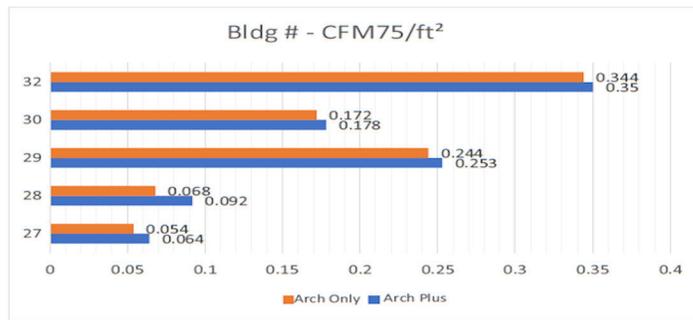
Figure 11-1 Graph Architectural Only Vs. Architectural Plus HVAC Test (CFM75/ ft²)

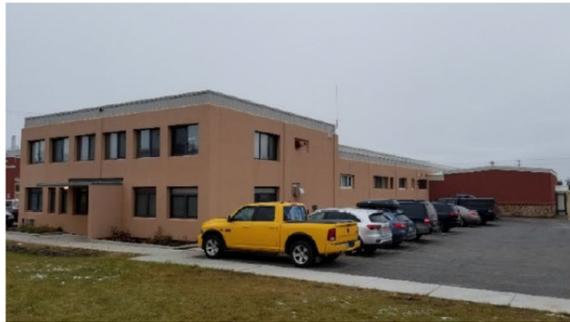
**a. Bldg. 603**

**Figure B-6. Fort Greely Bldgs. 603 and 650, photos and model representations.**

Bldg. 603 (Figure B-6a) resides on south post at Fort Greely, Alaska. The building was once used as a multipurpose warehouse and workshops but is now outfitted with office space, some workshops, and an unconditioned basement. Constructed in 1955, Bldg. 603 is a Department of Public Works building. The two-story building uses CMU in the interior wall construction with an EIFS exterior building construction. There are a variety of windows and sizes, with entry and overhead garage doors. The roof on the pre-existing structure is flat, and the building addition has a gabled roof.
