# Building Enclosure Testing on Alaska Military Base Projects

Emmett Leffel

## ABSTRACT

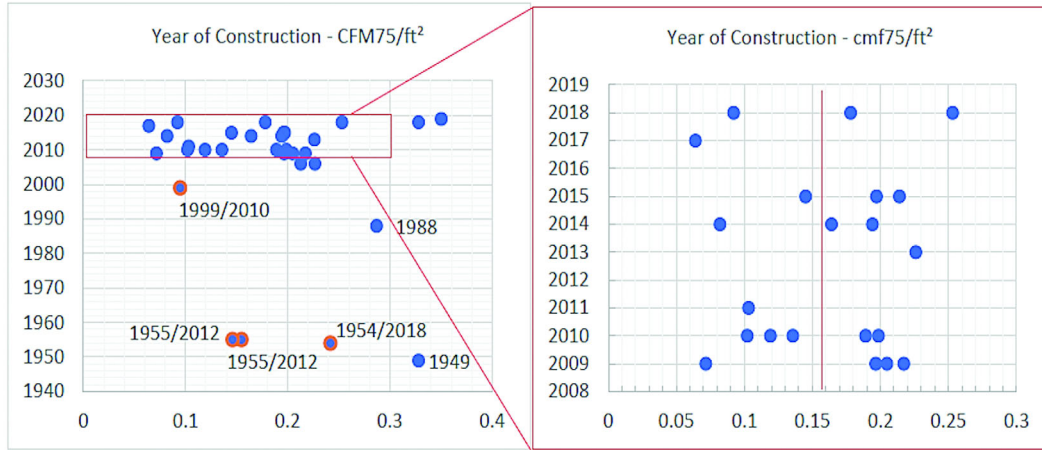
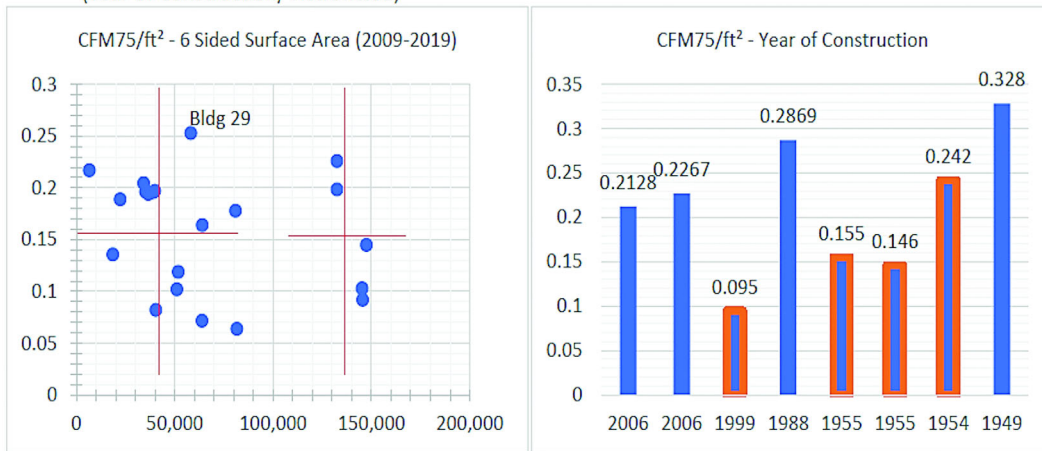
**Figure 1**    *Graphs 1-3 air leakage test results, 2009–2020.*

Graphs 1-1a and 1-2 in Figure 1 show the airtightness test results in  $\text{cfm/ft}^2$  at 75 Pa of the new construction projects based on the year of construction. The overall average for all buildings tested by the author, of projects required to be  $0.25 \text{ cfm/ft}^2$  ( $4.7 \text{ m}^3/\text{h/m}^2$  at 75 Pa) or less, is  $0.158 \text{ cfm/ft}^2$  at 75 Pa. Only two of the new buildings were concrete masonry unit (CMU) building types; 21 projects were primarily constructed with insulated metal panel (IMP) wall systems. Table 1 in the appendix lists the roof and wall systems types for each building. Both CMU buildings tested below  $0.1 \text{ cfm/ft}^2$  at 75 Pa ( $1.83 \text{ m}^3/\text{h/m}^2$  at 75 Pa)—some of the tightest construction types seen on Alaskan military projects. These two cases are reviewed in the "The Tightest Air Barriers Examples" section, which is a part of the discussion of things done right along with opportunities missed. IMP wall systems, while proven to be an excellent building envelope system when appropriately constructed, have given wide range of test results, from  $0.07 \text{ cfm/ft}^2$  to  $0.35 \text{ cfm/ft}^2$  at 75 Pa ( $1.31 \text{ m}^3/\text{h/m}^2$  to  $6.4 \text{ m}^3/\text{h/m}^2$  at 75 Pa). The fact that four buildings achieved an airtightness less than  $0.1 \text{ cfm/ft}^2$  at 75 Pa (and nine buildings tested below  $0.15 \text{ cfm/ft}^2$  at 75 Pa [ $2.74 \text{ m}^3/\text{h/m}^2$  at 75 Pa]) while others have difficulty reaching  $0.25 \text{ cfm/ft}^2$  at 75 Pa ( $4.7 \text{ m}^3/\text{h/m}^2$  at 75 Pa) reflects a complex problem that is heavily impacted by construction experience, attitudes, plan design, or constructibility issues that can occur in commercial construction. In fact, the constructibility of different air barrier materials can even be affected by variables such as weather and the time of year that construction takes place in an Arctic climate.

Figure 1 shows a set of graphs of the air leakage test results for each subset group. Graph 1-1 shows test results for all cases listed in Table 1 (see the appendix). The area inside the red rectangle in Graph 1-1 is expanded in Graph 1-1a, which represents the airtightness results from 2009 to 2019 construction projects required to meet the  $0.25 \text{ cfm/ft}^2$  at 75 Pa ( $4.7 \text{ m}^3/\text{h/m}^2$  at 75 Pa) or less. The average  $\text{cfm/ft}^2$  at 75 Pa calculated for new construction test results is  $0.158 \text{ cfm/ft}^2$  at 75 Pa, as indicated with a red vertical line in Graph 1-1a. Projects that had an airtightness target of  $0.4 \text{ cfm/ft}^2$  at 75 Pa ( $7.31 \text{ m}^3/\text{h/m}^2$  at 75 Pa) are outliers in this group and are not included in the average. Bldgs. 31 (2019) and 2's (1949) test results are comparable with ASHRAE's and International Energy Conservation Code's® (IECC) commercial airtightness requirement and demonstrate how excessive air leakage can result in ice damming conditions in the immediate or mold

Graph 1-1. 1954–2019 Airtightness Results (cfm75/ ft<sup>2</sup>) (Year of Construction/ Retrofitted)      Graph 1-1a. 2009–2019 Airtightness Results (cfm75/ ft<sup>2</sup>)

Graph 1-2. Leakage (cfm75/ft<sup>2</sup>) to Size, w/ Avg. Show      Graph 1-3. 1949–2006 Airtightness Results (cfm75/ft<sup>2</sup>) (orange outline = Deep Energy Retrofit)

conditions and degradation to the building envelope over time. Graph 1-2 charts building surface area against airtightness, which is further discussed in the “Does Building Size Matter?” section. Graph 1-3 shows pre-2009 construction test results, for comparison. Note that buildings constructed before 2009 that had building envelope and ventilation upgrades completed fell within the standard deviation of 0.057 for new construction projects average airtightness. These results suggest that older existing DOD building infrastructure can be retrofitted to achieve the level of performance of new projects. The “The Oldest versus the Renovated” section discusses pre-2009 ECB projects.

The test results and surface areas for projects constructed from 2009 to 2019, charted in Graph 1-2, illustrate the leakage rates of large versus small- or medium-sized building envelopes. Building airtightness results for both large- and

medium-size projects averaged 0.153 cfm/ft<sup>2</sup> and 0.160 cfm/ft<sup>2</sup> at 75 Pa (2.8 m<sup>3</sup>/h/m<sup>2</sup> and 2.92 m<sup>3</sup>/h/m<sup>2</sup> at 75 Pa), respectively. Building size does not appear to significantly impact air barrier system performance. The vertical span of each group is spaced evenly with one outlier in the medium-sized group. (Bldg. 29 could be considered an outlier because of conditions explained below.) If Bldg. 29 is removed as an outlier, the average airtightness for medium and smaller envelope tests is lowered to 0.154 cfm/ft<sup>2</sup> at 75 Pa, almost the same as larger building envelopes. These results from tests in Alaska demonstrate that smaller buildings can be minimally as airtight as larger buildings if they meet mandated airtightness requirements.

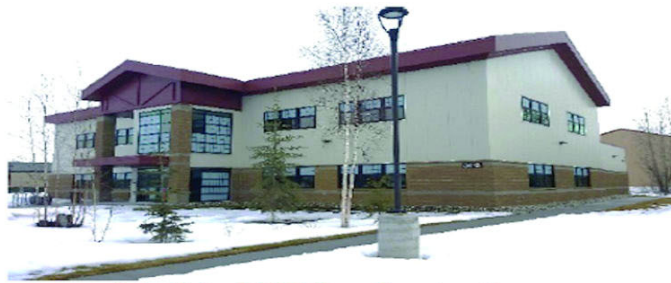
**Figure 2** Failures and lessons learned: Bldgs. 21, 24, and 26 IR and plan details.

Bldg. 26 did not initially meet the USACE airtightness requirement. Thermal imaging completed before building envelope testing (BET) revealed significant air leakage at the rake walls (see the IR images in Image 2-2 in Figure 2). The retrofit developed in the field at the time was simple: plug the holes. The primary contributing air leakage pathway was identified and sealed at the top flutes of the steel roof pan decking by drilling ¼-in. (6.3 mm) holes in the flutes and inject high expansion can foam at each pan decking trough. This retrofit was effective and allowed the project to complete on time. Bldgs. 24 and 26 are similarly designed and built by two different general contractors at about the same time. Surface area calculations were slightly different, but the air leakage pathways were almost exactly the

same. After air sealing improvements were made to both Bldgs. 24 and 26, final air leakage was measured at 0.196 cfm/ft<sup>2</sup> and 0.197 cfm/ft<sup>2</sup> at 75 Pa, respectively.

Image 2-1. Bldg. 24,26 Typ. Construction

Image 2-2. Bldg. 26 IR Roof/Wall Joint @+25Pa

Image 2-3. Building 21,24,26 Rake Wall Plan Detail

Image 2-4. Building 21,24,26 Roof Profile

Image 2-5 Bldg. 24 IR Roof/Wall Joint @+25Pa

Image 2-6 Bldg. 24 IR Roof/Wall Joint @+25Pa

Image 2-7 Bldg. 21 IR Roof/Wall @+25Pa

Image 2-8 Bldg. 21 IR Roof/Wall @-25Pa

The post-construction air-sealing method of injecting can foam into the top flutes of the steel roof decking should only be used in retrofit applications. See Images 2-3 and 2-4 in Figure 2 for details. In more recent projects, this retrofit has been used on similar roofs by filling flutes during the construction of the roof, thus creating a cold joint between foam and dens decking. These methods were used in Bldg. 31 with vastly different results, discussed in detail below. Recent design reviews on 2020 projects included recommendations for filling the troughs with foam at the rake walls during the construction of the roof, where troughs are perpendicular to the wall line, and setting the DensDeck in a bed of caulking at all exterior wall lines to further minimize air leakage above the roof decking at the roof-to-wall juncture.

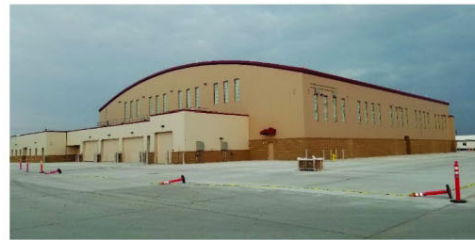
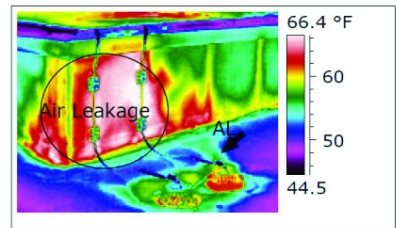
**Figure 3** Failures and lessons learned: Bldgs. 29 IR and plan details.

Bldg. 29 is constructed with an IMP wall system and 6 in. (15.24cm) of polyurethane at the interior. The steel roof is constructed with a vapor barrier on the warm side of the insulation. The hangar section was excluded from the air barrier test requirements (see Image 3-1 in Figure 3). This project failed its initial air leakage testing with an area separation wall included as part of the six-sided building envelope. Significant air leakage pathways were located at the area separation wall between the hangar and office area, which was mapped independently of other walls sections using fog. Air leakage also existed at the parapet and rake walls due to an unsealed gap in the air barrier at the top of wall juncture. These air leakage pathways are outlined in plan and elevation view drawings in Graphs 3-2 and 3-3 in Figure 3. Sealing the area separation wall was completed quickly and cost-effectively, allowing the building to pass the test requirement and construction to finish. The final architectural only air leakage test results were 0.244 cfm/ft<sup>2</sup> at 75 Pa. Because the test zone also included the area separation wall and not the whole-building envelope, more costly and invasive air sealing retrofits at the exterior building envelope did not need to be prioritized to pass the USACE air leakage test requirement. For these reasons, including an area separation wall as part of the six-sided building envelope may not be an effective method in verifying an airtight separation wall or the building envelope enclosure tightness. The air leakage of either wall type impacts the building differently; because of this, area separation walls should be tested differently and even at different airtightness requirements. Fog leakage testing and guarded tests could be used in demonstrating and calculating cfm/ft<sup>2</sup> of an Underwriters Laboratories (UL) listed area separation wall. Testing these walls independently of the exterior building envelope may help to improve knowledge of UL listed walls in the construction industry, specifically of how area separation walls leak air and how they could be better built to achieve air sealing between different building zones. Bldg. 25 is a single-zone warm storage hangar similar in design to Bldg. 29. Bldg. 25 passed the airtightness requirements at 0.145 cfm/ft<sup>2</sup> at 75 Pa. Including a hangar or maintenance inspection bay in the whole-building air

Image 3-1. Building 29 Air Barrier Test Zone

Image 3-2. Building 29 Air Leakage Pathways

Image 3-3. Building 29 Air Leakage Pathways

Image 3-4. Building 29

Image 3-5 Building 29 Parapet Corners @+25Pa

Image 3-6 Building 29 Parapet Corner @+25Pa

Image 3-7 Building 29 Parapet Detail (Mapped Air Leakage)

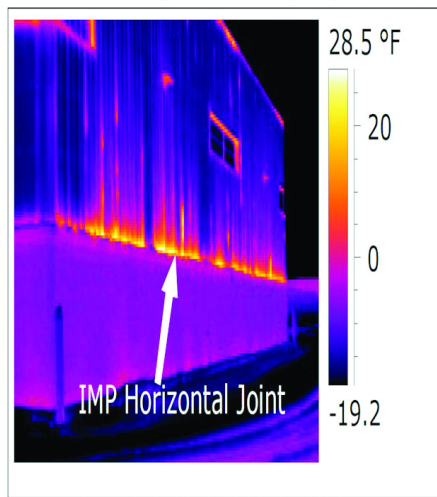
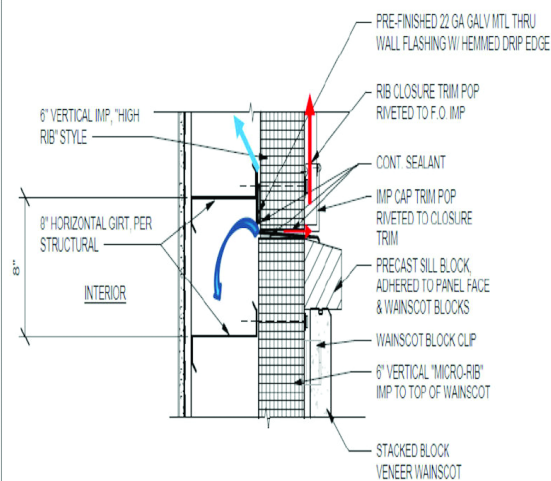
**Figure 4** Minimum code construction: Bldg. 31 (0.4 cfm/ft<sup>2</sup> at 75 Pa [7.31 m<sup>3</sup>/h/m<sup>2</sup> at 75 Pa] requirement).

Bldg. 31 passed the Air Force airtightness requirements of 0.4 cfm/ft<sup>2</sup> at 75 Pa (7.31 m<sup>3</sup>/h/m<sup>2</sup> at 75 Pa), with 0.328 cfm/ft<sup>2</sup> at 75 Pa (6 m<sup>3</sup>/h/m<sup>2</sup> at 75 Pa). Extensive air leakage building-wide at critical air barrier joints was found with subsequent ice damming conditions occurring in the first year at the northwest building corner, which created a severe slip trip and fall potential. (See the IR Image 4-1 of Figure 4, where air leakage from

the mechanical room is filling the rake wall soffit and adjacent eave soffit with warm air.) A design detail that demonstrates an effective and constructible plan that transitions the roof air/vapor barrier down through the roof steel decking flutes and ties appropriately into the wall air barrier at all eave and rake walls needs to be developed. Additionally, improvements in quality control of the roof air barrier are needed. All portions of the air barrier, including the roof air barrier should be verified at the time of installation by someone with knowledge of the installation of air barriers. The heated and conditioned maintenance

inspection and garage bays were not included in the air barrier test zone under the Unified Facilities Criteria (UFC) 3-101-01 exceptions for air barrier testing (USACE et al. 2019). Bldg. 31 had air leakage pathways consistently at rake walls, parapet walls, and horizontal IMP joints for long sections at critical air barrier joints. During BET and air leakage diagnostics, changes in indoor temperatures and relative humidity were noticeable in zones having significant air leakage. These conditions and airtightness requirements reflect the potential in ASHRAE and IECC minimum code construction and highlight future opportunities in deep energy retrofits for existing and new construction.

Image 4-1 Building 31 (0.328cfm/ft<sup>2</sup> @75Pa) Northwest Building Corner @+25Pa

Image 4-2 Bldg. 31 IMP Horizontal Wall Joint @+25Pa

Image 4-3 Bldg. 31 IMP Horizontal Wall Joint Detail

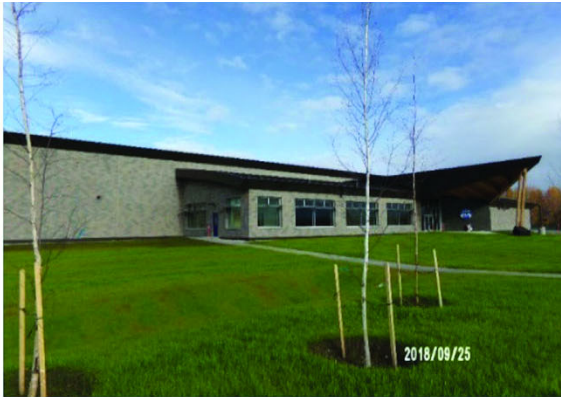
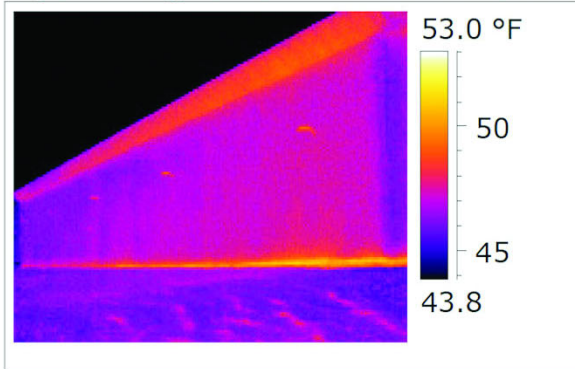
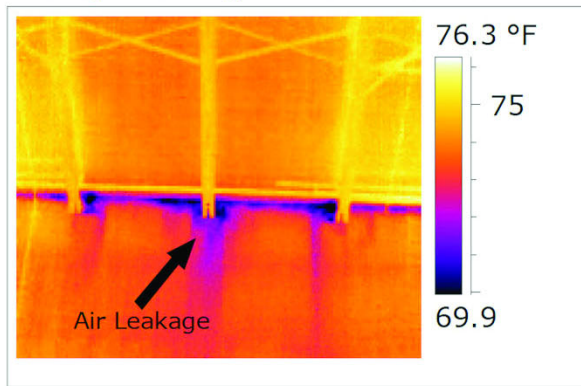
**Figure 5** The tightest building examples: Bldg. 27, IR, and plan details.

Bldg. 27, which was constructed in 2017, tested at 0.054 cfm/ft<sup>2</sup> at 75 Pa. The thermal envelope is a CMU wall system with Rockwool at the interior side of the CMU and a self-adhered air barrier at the warm side of the wall system. A vapor barrier is located at the steel roof pan decking. An air barrier design review, air barrier mock-up, and air barrier inspections were completed during the air barrier installation. Note that the steel roof deck and vapor barrier roof assembly of Bldg. 27 are the same as that of Bldgs. 21, 24, and 26, but Bldg. 27 did not have the same failed air barrier joint condition

at the rake walls. The gap in the air/vapor barrier at the top flutes of the steel deck was sealed by injecting foam at the rake wall assemblies in a retrofit application while the exterior soffits were open. The IR images in Figure 5 show the impact and overall airtightness performance of this building. Minimal amounts of air leakage were found. This project included an air barrier design review, inspections, and a mock-up of the air barrier that included Heating, ventilating, and air-conditioning (HVAC) fenestrations, a building corner, and the roof-to-wall juncture.

Image 5-1. Bldg. 27 CMU Wall & Metal Roof

Image 5-2. Bldg. 27 CMU Rake Wall @+25Pa

Image 5-3. Bldg. 27 Eave & CMU wall @+25Pa

Image 5-4. Bldg. 27 Plan Detail of the Eave

Image 5-5. Bldg. 27 Upper Roof Eave @+25Pa

Image 5-6. Bldg. 27 Upper Roof Eave @-25Pa

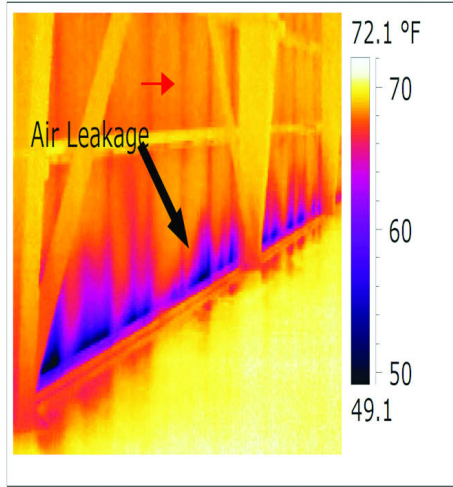
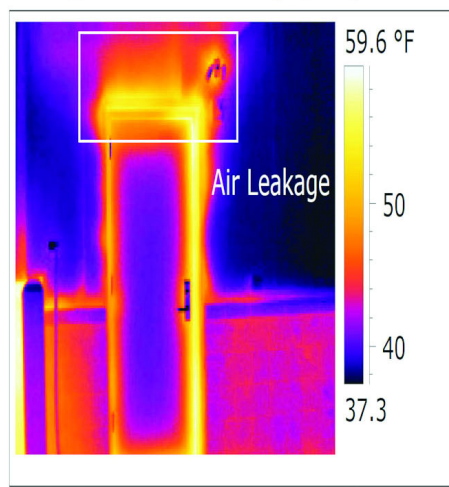
**Figure 6** The tightest building examples: Bldg. 10 digital and IR imagery.

Bldg. 10, which was constructed in 2009, had an airtightness of 0.0716 cfm/ft<sup>2</sup> at 75 Pa (1.31 m<sup>3</sup>/h/m<sup>2</sup> at 75 Pa). The thermal envelope is constructed entirely of IMP wall and roof systems; it was the tightest of IMP projects. Contractor crews were diligent and methodical at air sealing at the roof-to-wall joints, IMP joints, and building corners. Air leakage was found primarily at the base of the IMP wall-to-slab edge, at the translucent panels, and at exterior doors. Very little air leakage was located at the roof-to-wall joints, building corners, or roof

sections. The IR images in Figure 6 show areas that could easily have been improved during construction.

Image 6-1. Building 10 IMP Wall and Roof

Image 6-2. Building 10 Panoramic IR Image @+25pa

Image 6-3. Building 27 Air Leakage Pathways @-25Pa

Image 6-4. Building 27 Plan Detail of the Eave @+25pa

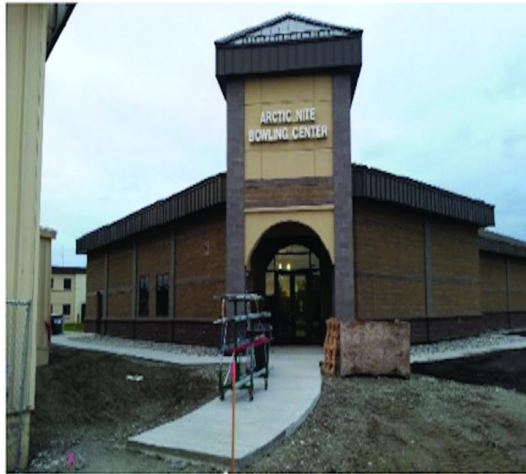
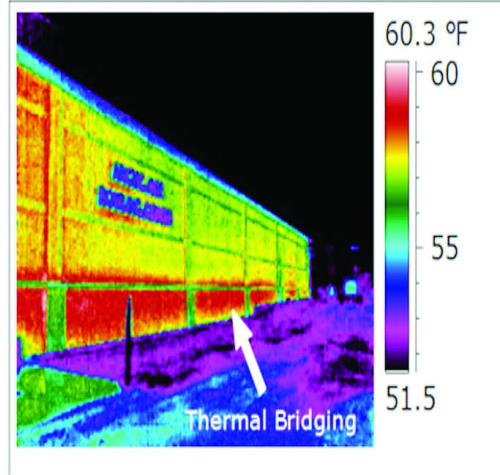
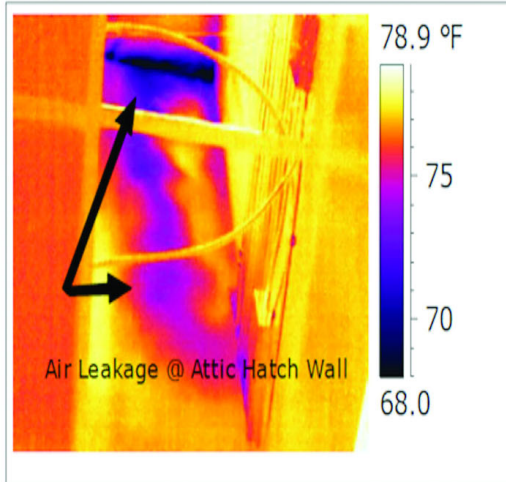
**Figure 7** The tightest building examples: Bldg. 23 IR and plan details.

Bldg. 23 air leakage tested at 0.082 cfm/ft<sup>2</sup> at 75 Pa. The CMU wall system had very few windows and doors because of its use as a bowling center. This project also has an attic space with metal trusses. Air barrier design review and air barrier inspections played an important role in identifying a gap at the CMU wall-to-ceiling joint and an interior wall partition top plate. Air barrier inspections identified air leakage pathways around HVAC low-leakage dampers and other air leakage pathways during construction as well. These types of quality controls have had a positive impact on projects where air barrier performance is tested. While this project far surpassed the airtightness requirement, opportunities still existed for air sealing and thermal barrier improvements. Figure 7 shows examples of remaining air leakage and overall thermal signatures of the CMU wall system.

Image 7-1. Building 23 CMU Wall & Attic Ceiling

Image 7-2. Building 23 @+25Pa

Image 7-3. Building 23 Attic Hatch Wall @-25Pa

Image 7-4. Building 23 Slab Edge Plans Detail

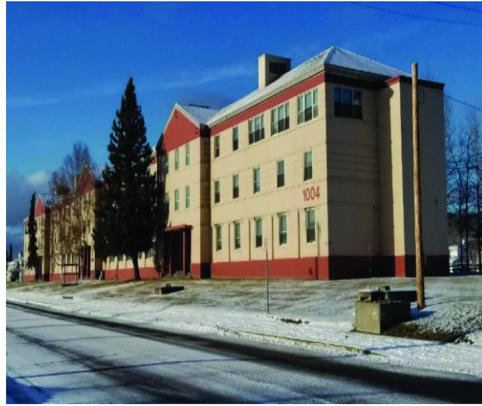
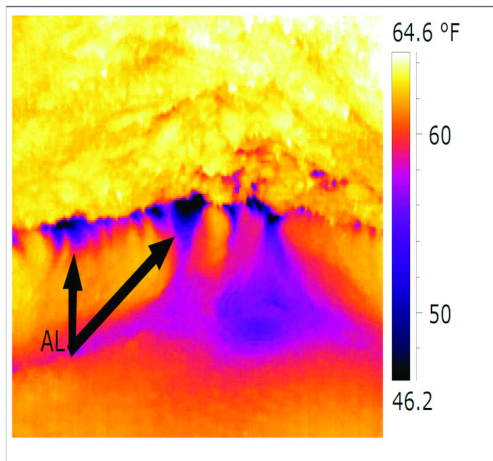
**Figure 8** Bldg. 2. air leakage at  $0.328 \text{ cfm/ft}^2$  at 75 Pa ( $5.99 \text{ m}^3/\text{h/m}^2$  at 75 Pa) showing several air leakage pathways.

Bldg. 2 had an air leakage result of  $0.328 \text{ cfm/ft}^2$  at 75 Pa ( $6 \text{ m}^3/\text{h/m}^2$  at 75 Pa). The building has single-pane, double-hung aluminum windows that have significant air leakage. The roof is steel with polyurethane and fire coating, but even this had air leakage at pinholes, expansion joints, and CMU fire break walls in the hot attic. This barracks, which now sit vacant after 70 years of service, need either renovations or demolition. Air leakage was found at the roof-to-CMU rake walls, structural beams, roof eaves-to-wall joints, roof peaks, windows, doors, and HVAC terminations inside cupolas. Moisture signs are typical in this building wherever air leakage is found due to the extreme climate zone, the building's age, and high occupancy. Mold conditions were evident at locations such as expansion joints where significant air leakage pathways were found, and continuous wetting occurred for up to nine months out of a year from condensation.

Image 8-1. Building 2 Concrete Wall/Steel Roof

Image 8-2. Building 2 Roof to Wall Joint IR @+25Pa.

Image 8-3. Building 2 Air Leakage Pathways

Image 8-4. Building 2 Roof to Wall Joint Dig.

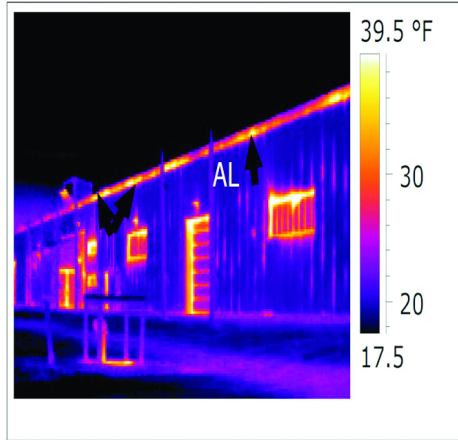
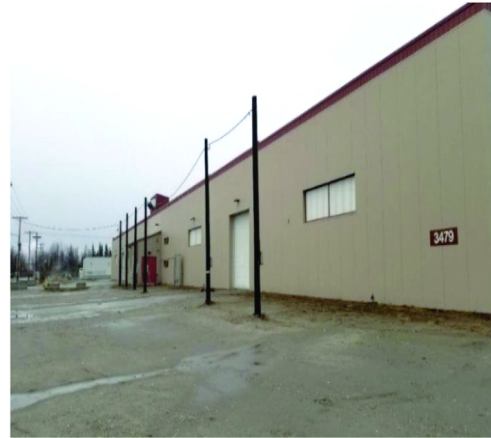
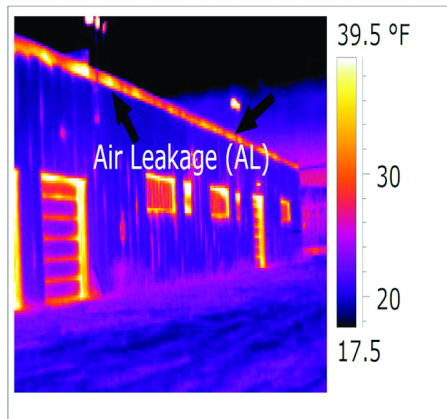
**Figure 9** Bldg. 3 ( $0.242 \text{ cfm/ft}^2$  at  $75 \text{ Pa}$  [ $4.43 \text{ m}^3/\text{h/m}^2$  at  $75 \text{ Pa}$ ]) showing common air leakage pathways of IMP.

Bldg. 3, which was constructed in 1954 of CMU, is used as a storage/maintenance facility. The building envelope and HVAC ventilation systems were upgraded in 2018 with an

IMP wall at the exterior side of the CMU wall, new HVAC equipment, dampers, overhead doors, and windows. The building envelope meets current USACE airtightness standards at  $0.242 \text{ cfm/ft}^2$  at 75 Pa ( $4.43 \text{ m}^3/\text{h/m}^2$  at 75 Pa). However, when the building is pressurized, thermal imaging shows a much different thermal signature than might have been expected from a "tight" envelope. Air leakage pathways were primarily found at the wall-to-roof joints, IMP joints, and all fenestrations. No visible signs of moisture at the building envelope were found during the IR inspection. This building is slightly pressurized during normal building pressures with the HVAC equipment in operation. Because of this, the building's age, and possibly because of the significant air leakage pathway at the roof-to-wall joint, a slight mildew smell could be detected at electrical outlets boxes and inside the insulated wall cavity. Thermal imaging, airtightness testing, and air barrier inspections can identify these concerns in the design and construction phases. Air leakage signatures were consis-

tent building-wide at critical air barrier joints such as the parapet wall system, roofing, and IMPs.

Image 9-1. Building 3 Air Leakage Pathways @+25Pa

Image 9-2. Building 3 Storage Facility and Shop

Image 9-3. Building 3 Air Leakage Pathways @+25Pa

Image 9-4. Building 3 Air Leakage Pathways @+25Pa

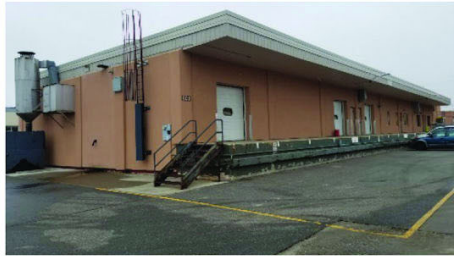
**Figure 10** Bldgs. 4 and 5, thermal signatures of exterior insulation and finish system (EIFS) wall at air leakage pathways.

Bldgs. 4 and 5 were both constructed in 1955 and remodeled around 2012 with an exterior insulation finish system (EIFS) wall retrofit, some windows, and limited HVAC upgrades. The air leakage tests for Bldgs. 4 and 5 were 0.155 cfm/ft<sup>2</sup> at 75 Pa and 0.146 cfm/ft<sup>2</sup> at 75 Pa (2.83 m<sup>3</sup>/h/m<sup>2</sup> to 2.67 m<sup>3</sup>/h/m<sup>2</sup> at 75 Pa), respectively. Air leakage was primarily found at the original HVAC louvered vents, windows, and doors that had not been upgraded. The thermal envelope upgraded walls performed exceptionally well with regards to thermal and air barrier performance when imaged (see Images 10-1 through 10-5 in Figure 10). The air leakage pathways were minor in comparison to projects having 0.25 cfm/ft<sup>2</sup> at 75 Pa (4.7 m<sup>3</sup>/h/m<sup>2</sup> at 75 Pa). The EIFS retrofit, along with HVAC upgrades, were successful, and air leakage pathways identified during diagnostics demonstrated that

these buildings could have easily achieved even tighter construction.

Image 10-1. Building 5 Panoramic of EIFS Wall in the Iron Pallet @ +25 Pascals

Image 10-2. Building 4 Shop Photo

Image 10-3. Building 4 Shop @+25 Pascals

Image 10-4. Building 4 Overhead Door @-25Pa

Image 10-5. Building 4 Fenestration & EIFS @+25 Pascals

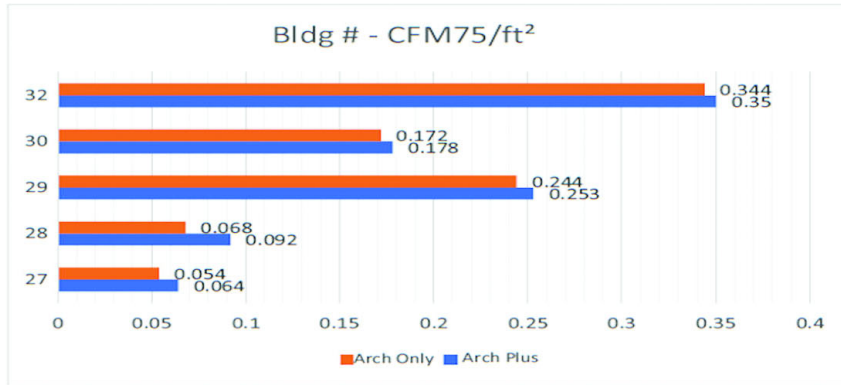
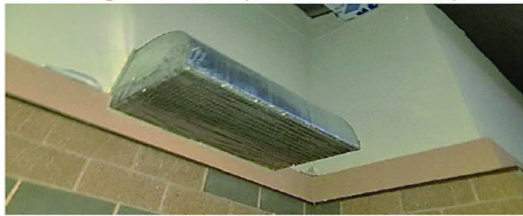
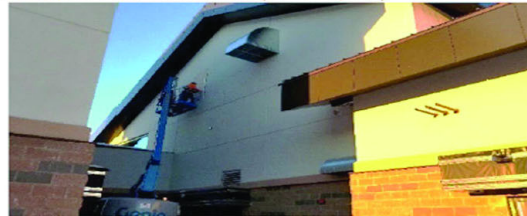
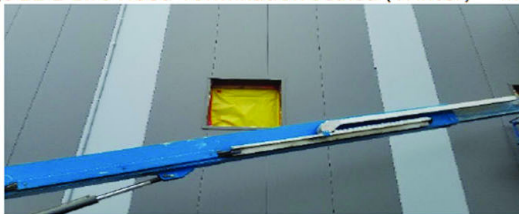
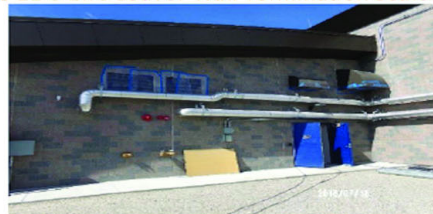
Figure 11 Architectural Only versus Architectural Plus HVAC test and examples.

For buildings that have completed both the Arch Only and Arch Plus tests, the percentage differences between the two-test setup “masked or unmasked” vary significantly from 3.3% to 26% (See Bldg. 27 through 30 and 32 in Table 1). These test results are easily affected by uncontrollable scenarios making them less repeatable. For example, several conditions that can influence the Arch Only tests negatively are

- The difficulty and repeatability issues in applying tape or self-adhesive grille wrap in cold or wet climates. For example, see Images 11-2 and 11-3 in Figure 11.
- Tape or self-adhesive grille wrap sealed to the exterior wall assembly instead of properly sealing just the intentional openings at the air barrier boundary. For example, see Images 11-4 and 11-5 in Figure 11. Images 11-6 and 11-7 in Figure 11 demonstrate the potential air leakage at louvered HVAC vents.

Figure 11-1 Graph Architectural Only Vs. Architectural Plus HVAC Test (CFM75/ ft<sup>2</sup>)

Image 11-2 EIFS Hood Termination Sealed (Winter)

Image 11-3 EIFS Louver Wall Termination Sealed (Winter)

Image 11-4 IMP Louver Termination Sealed

Image 11-5 CMU Louver Wall Termination Sealed

Image 11-6 Bldg. 19. Louver Termination @-25Pa

Image 11-7 Louver Wall Termination Detail

- The labor, time, and the cost required for air barrier testing in cold and Arctic climates can be significantly reduced by eliminating the redundancy in testing and not masking where HVAC low-leakage dampers are used and no other intentional openings exist.
- Include hangar and maintenance bays in testing requirements in Arctic climates and incorporate zone separation wall testing and diagnostics where practical to improve the resilience and long-term durability of USACE projects.
