# Thermal Energy System Resilience: Temperature Decay in Cold/Arctic Climates—Part I

## ABSTRACT

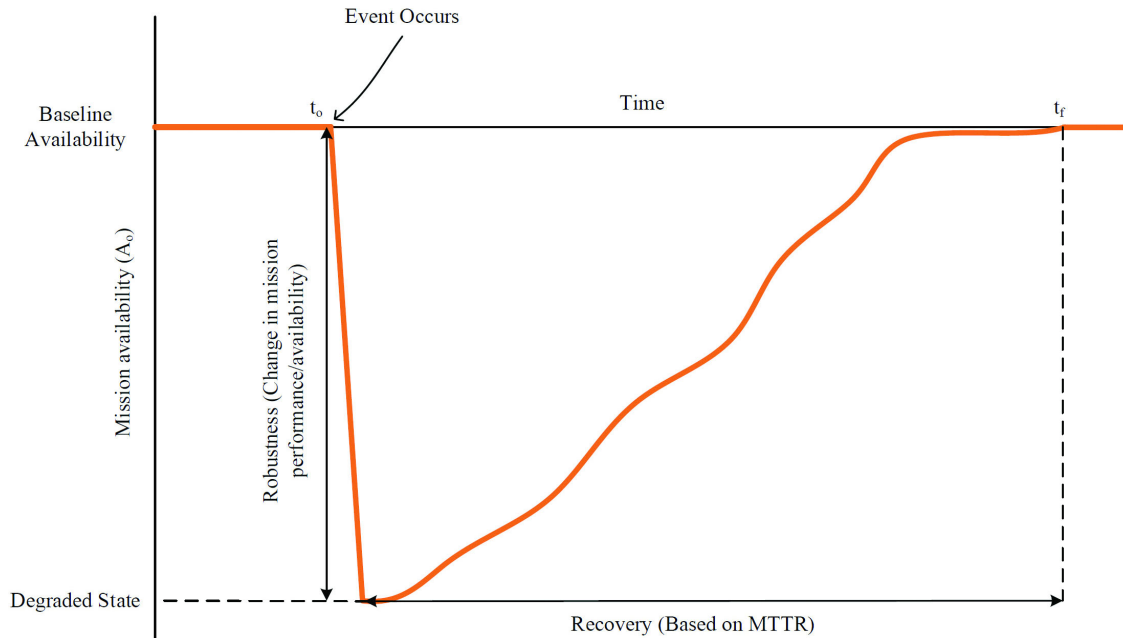
**Figure 2** System response to a disruptive event.

baseline energy requirement. Using the energy robustness metric, we can quantify the overall resilience of a system in two phases: absorption of the event and recovery. Figure 2 illustrates system performance disturbance, which occurs without warning, such as with seismic events. Immediately following the event, there is a sharp drop in mission availability. The change in mission availability from the baseline to the degraded state represents the robustness of the system to that particular event. The smaller the change in mission availability, the more robust the system. The time required to restore the system to its baseline state is referred to as *recovery*.

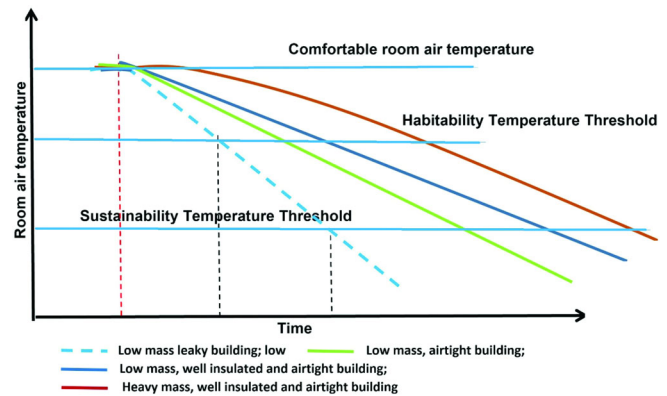
**Figure 3** Notional example of temperature decay rate for different types of building envelopes.

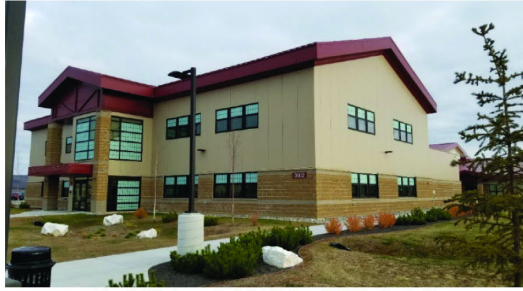
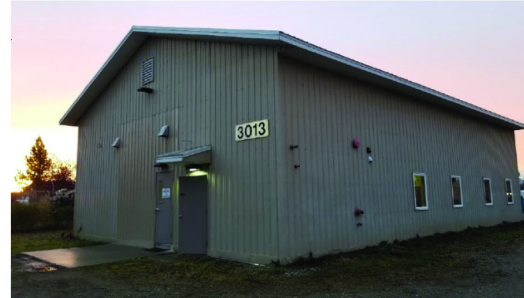
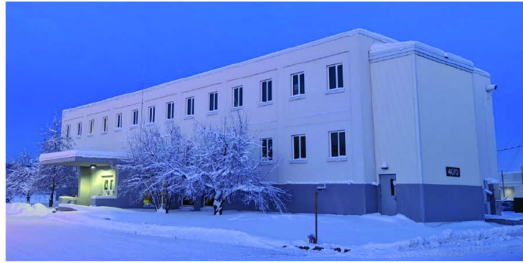
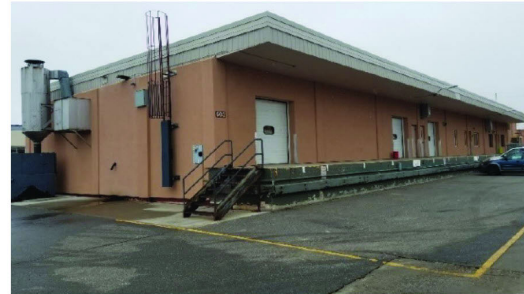
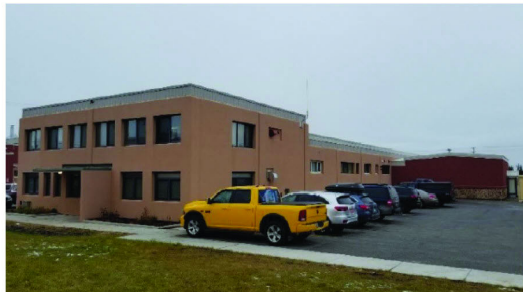
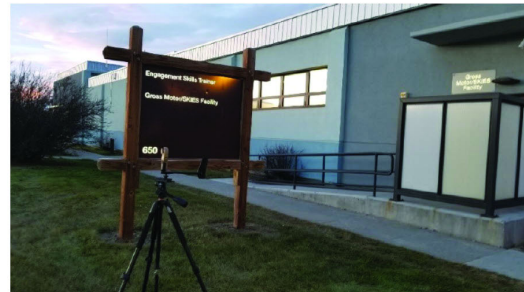
a. Fort Wainwright Bldg. 3002, Aviation Battalion Headquarters

b. Fort Wainwright Bldg. 3013, Directorate of Public Works Plans Vault.

c. Fort Wainwright Bldg. 4070, Cold Regions Research Engineering Laboratory

d. Fort Greely Bldg. 603, Directorate of Public Works Headquarters (southwest corner)

e. Fort Greely Bldg. 603, Directorate of Public Works Headquarters (northeast corner)

f. Fort Greely Bldg. 650, Theater and Gross Motor Facility

**Figure 4** Installation buildings in the study.

**Fort Wainwright.** Bldg. A, a battalion headquarters, was constructed in 2015. This predominately military-utilized office includes administrative areas, classrooms, and special function space. It is not uncommon to find small gyms, weapons storage rooms, and dining areas located within the building. This particular building received LEED's Silver certification and consists of metal wall panels and a metal roof. When the airtightness test was conducted at the facility, it initially failed to meet the minimum U.S. Army Corps (USACE) requirements. This air leakage rate is 0.208 CFM75/ft<sup>2</sup><sup>1</sup> and has an EqLA75 of 5.7 ft<sup>2</sup> and was primarily located at the roof to wall barrier joint. Upon correction and sealing, a 26% reduction was achieved (Leffel 2021). The walls and roof were estimated to have an R30 and R60 (IP) insulation rating, respectively.

Bldg. B, a small open floor designed building that includes an unconditioned storage area, was built in 1999 and consists of a wooden frame with metal siding. This building was originally constructed to serve as a small warehouse for a recycling facility. When it was repurposed and renovated in 2010, radiant floors and radiant ceiling panels were installed. During the airtightness test, the leakage rate was 0.095 CFM75/ft<sup>2</sup> with an EqLA75 of 0.5 ft<sup>2</sup>. Leakage was primarily found at the interior gypsum sheathing, window and door sills, and the common wall between the main conditioned room and the unconditioned storage room. This building was found to be overheating due to the heating systems and the poorly ventilated mechanical room. The walls and the roof were estimated to have an R26 and R30 insulation rating, respectively.

**Fort Greely.** Bldg. D, a multipurpose warehouse, has two separate zones and is divided by a concrete masonry unit (CMU) wall. The facility was constructed in 1955 but includes more recent upgrades made in 2012 such as exterior insulation and finish system (EIFS) to the exterior walls, roofing improvements, overhead door and window replacements, and upgrades made to the ventilation systems. On one side of the CMU wall, there is a woodshop with a two-story office space. On the other side is a garage bay. The airtightness test found an air leakage rate of 0.155 CFM75/ft<sup>2</sup> and an EqLA75 of 3.3 ft<sup>2</sup> and showed that there is a significant amount of leakage at the roof-to-wall joint in the garage bay, multiple windows and doors, as well as the second floor's south roof-to-wall joint. The walls and the roof were estimated to have an R15 and R28 insulation rating, respectively.

Bldg. E, a multiuse facility, contains three separate isolated zones—a theater, classrooms, and an indoor recreational area. Built in the 1950s, the construction consists of concrete with a steel roof and metal studs. The building envelope was upgraded in 2012, but when the airtightness test was administered, leakage was found at the wall-to-roof joints at the steel roof, HVAC penetrations, and doors. The airtightness test found a leakage rate of 0.146 CFM75/ft<sup>2</sup> and an EqLA75 of 2.8 ft<sup>2</sup>. The walls and the roof was estimated to have an R15 and R22 insulation rating, respectively.

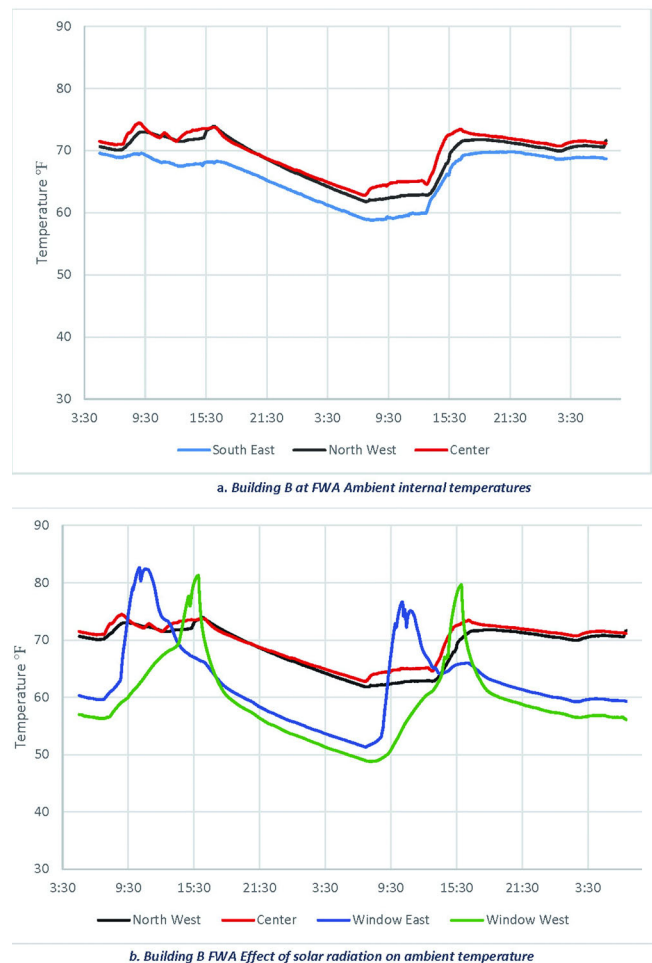
**Figure 5** Test results from Bldg. B, (a) ambient internal temperatures and (b) effect of solar radiation on ambient temperature.

The test at Bldg. B started at approximately 8:00 a.m. on February 26, 2020. The test ran throughout the course of the day while the building was occupied by several DPW employees. Figure 5a shows the ambient temperatures from several rooms distributed throughout the building. The test showed a relatively uniform temperature decay throughout the building, with a slight exception to the south restroom, which stayed a few degrees cooler than the other rooms throughout the test. This is likely due to the north restroom door being propped open, allowing heat to flow freely from the plans room to the restroom leading these rooms to follow a similar pattern.

The building continued to increase in temperature several hours into the test until about 10:00 a.m. on February 26, 2020, for the south restroom and 4:00 p.m. on February 26, 2020, for the north restroom and the plans room. There are several

explanations for this. One is that this building has a glycol heating system that continued to pump glycol throughout the building during the test. The residual heat stored in the glycol provided some amount of heat to the building until that heat eventually came to an equilibrium with the rest of the building. The second reason is heating from solar radiation. The plans room had several windows that allowed sunlight to enter at sunrise from the east (8:00 a.m.) and was connected to a

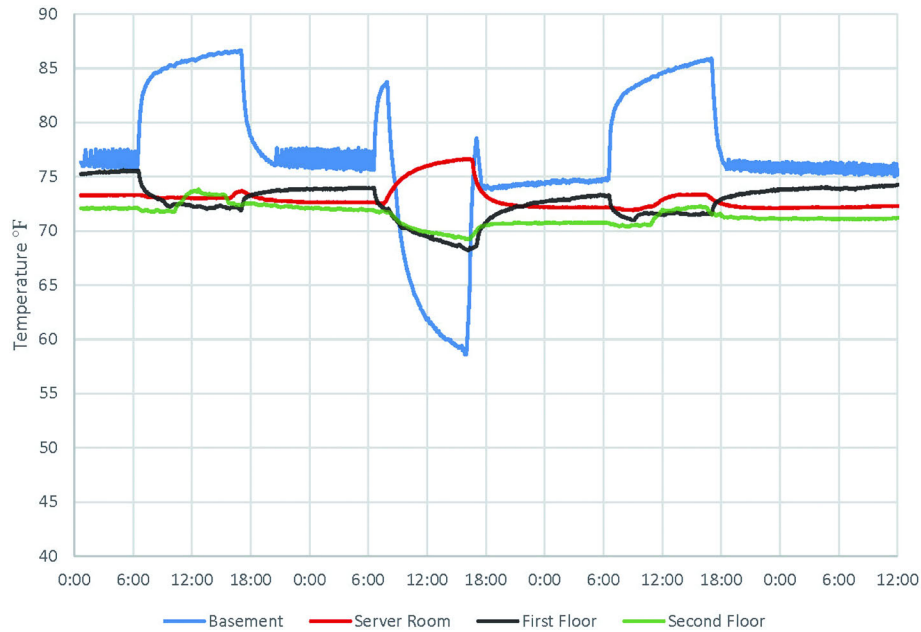
**Figure 6** Ambient temperatures throughout Bldg. C.

Bldg. C was a trilevel building with a semibasement that was partially above and below grade. For the most part, the temperature decayed relatively uniformly and as expected, with the thermal decay rate becoming faster moving from the second floor through to the basement. This was different from other building basements that were tested in that the additional insulation and thermal mass from the surrounding soil did not seem to inhibit the rate of decay, as was found in other buildings. This is due to the large fenestration area throughout the building and especially in the basement. Additionally, there was a large open stairway column that ran from the second floor to the basement allowing more cold air to infiltrate and sink to the bottom of the building.

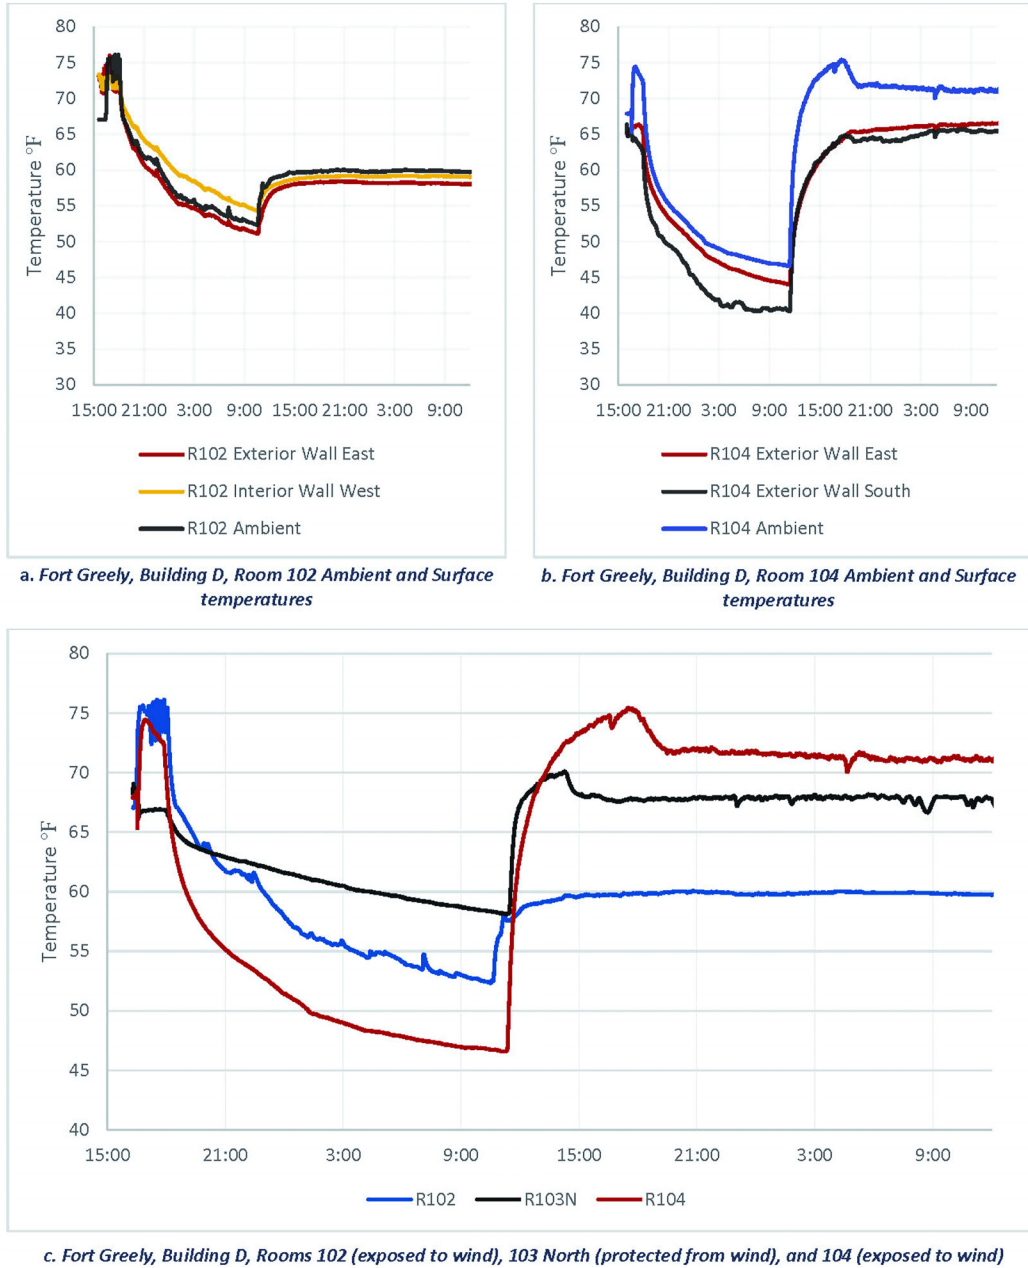
**Figure 7** Test results from FGA Bldg. D: (a) Room 102's ambient and surface temperatures, (b) Room 104's ambient and surface temperatures, and (c) Rooms 102 (exposed to wind), 103 North (protected from wind), and 104 (exposed to wind).

Figure 7c compares the ambient temperatures for three different rooms in Bldg. D. Room 102 decayed significantly faster than Room 103. This is due to Room 102 being directly in the path of 60+ mph (97+ kph) easterly winds experienced at FGA during the night of the test, as Room 102 was located on the southeast corner of the building. This caused positive pressure on the side of the building where Room 102 was located and negative pressure on the side where Room 103 was located. This set up a pressure gradient throughout the building, causing warm air to exit the building on the west side and cold air to enter the building on the east side. This accelerated

air infiltration in Rooms 102 and 104. In addition to the wind effect, Room 104 appeared to have less insulation than other rooms as this section of the building was built using different materials (metal sheeting) than the rest of the building.

Building materials with a larger thermal mass will release stored energy during a thermal energy disruption, inhibiting the rate of thermal decay. The data in Figures 7a and 7b may be used to compare two rooms with different building materials and different insulation values. Figure 7a shows the ambient temperature (solid line) follows just above the exterior wall

Figure 7b shows that with building materials with less thermal mass and insulation values (i.e., metal sheeting) the ambient temperature deviates significantly from the surface temperatures. This causes the temperature to lag the surface temperature, as the metal sheeting is less resistant to changes in temperature. This ultimately leads to a faster rate of thermal decay and a shorter maximum time to repair.

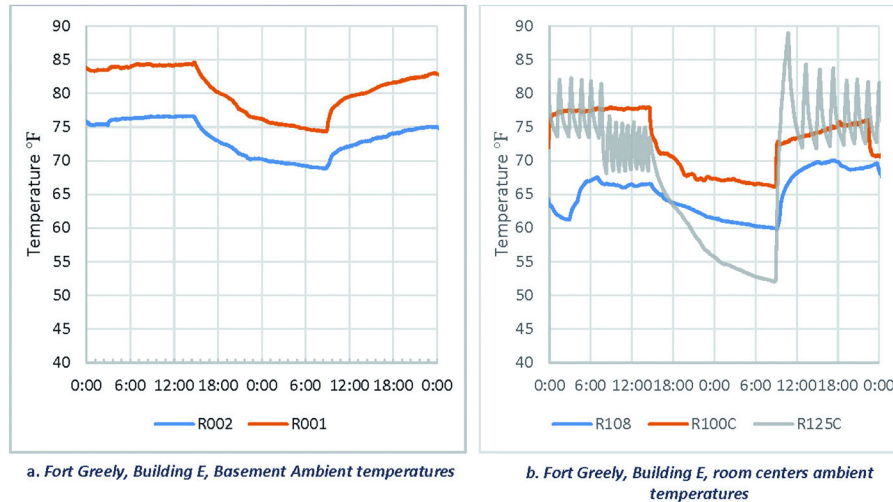
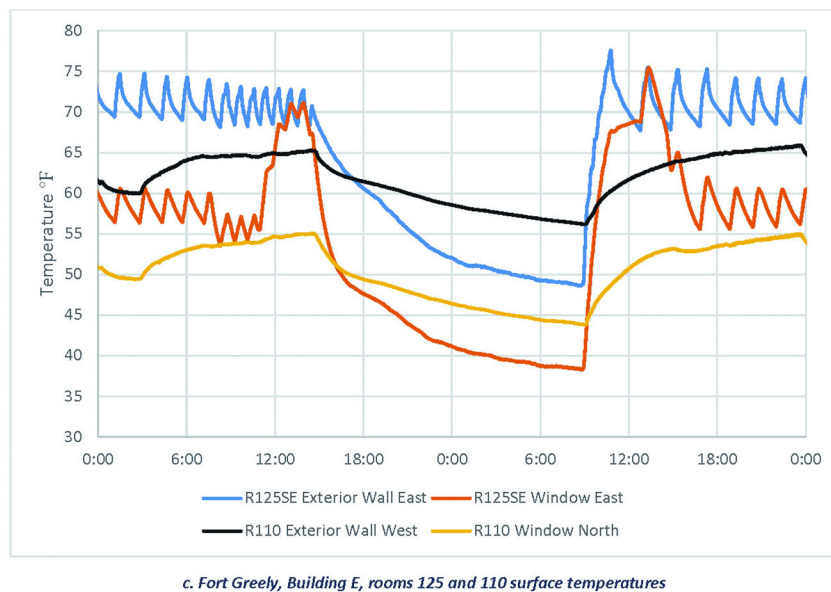
**Figure 8** Test results from FGA Bldg. E: (a) Basement ambient temperatures, (b) room centers ambient temperatures, and (c) Rooms 125 and 100 surface temperatures.

Over the course of the 17-hour test, Section 100 had the longest projected operation time. One reason for this is that it is shielded on both east and west sides by Sections 125 and 108, respectively. Another reason is the thermal energy rising from the basement. The thermally saturated foundation and surrounding soil acted as a thermal battery, dissipating heat over the course of the test. Sections 108 and 125 are on opposing corners of the three-part building, with Section 100 being located in the center. Section 125 had the most dramatic thermal decay curve and was located on the east side, directly in the path of the wind. Section 125 also had the largest fenestration area, with large windows on the north and south side. The wind was a significant contributor to the thermal decay rates in FGA. The effects of wind can be seen in Figure 8c, which shows the difference in surface temperatures between the southeast and northwest corners of Bldg. E. At the start of the test, the southeast corner was approximately 5°F (2.8°C) warmer than the northwest.
