Thermal Energy System Resilience: Thermal Decay Test (TDT) in Cold/Arctic Climates—Part II: Modeling

ABSTRACT

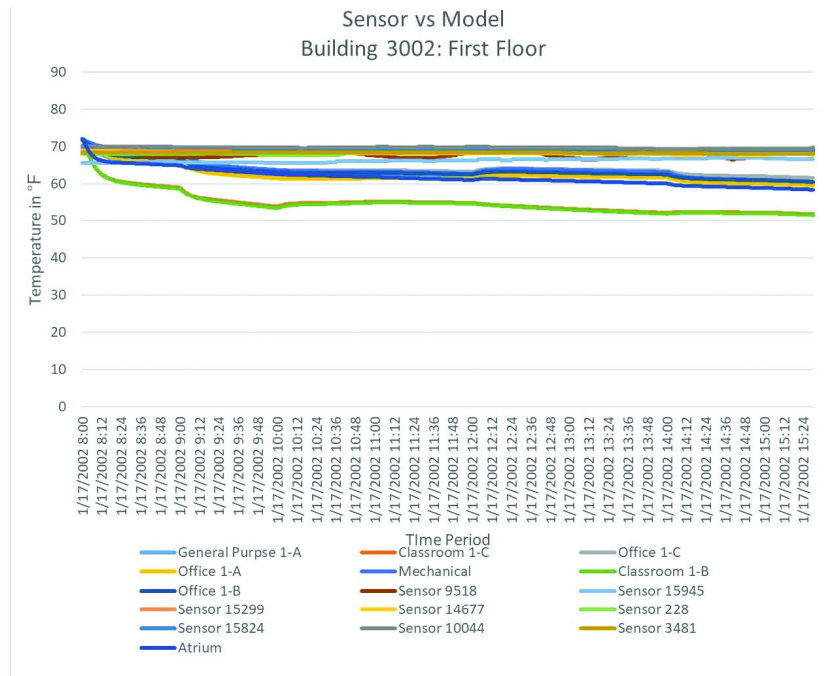
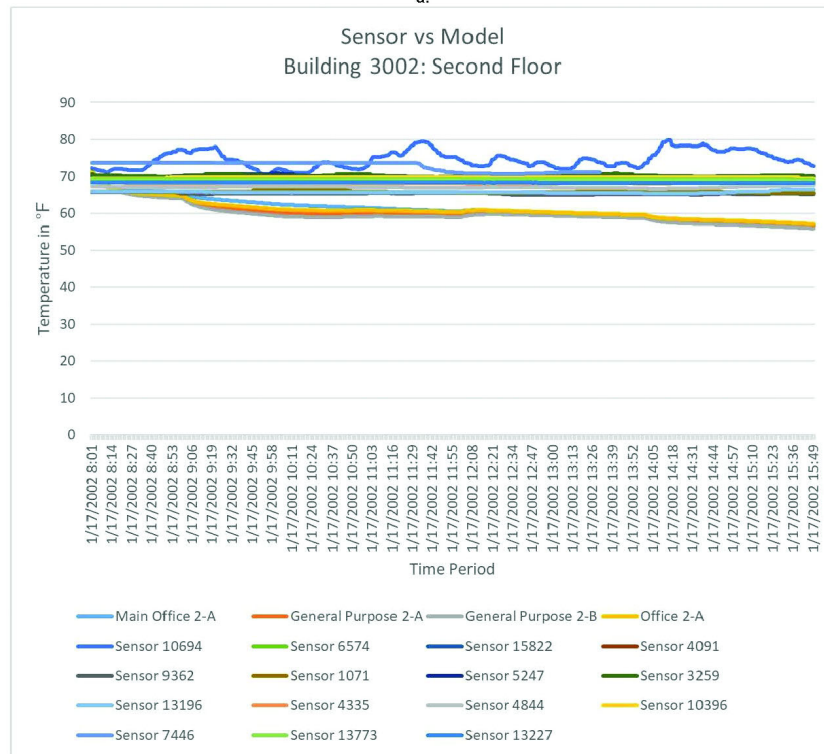
Figure 3 Bldg. 3002's (a) first floor and (b) second floor sensor and model comparison.

Second Floor. The sensors on the second floor of Bldg. 3002 had the same placement; they were located in the general-purpose areas (open office space), office, and entry areas. The second floor does not have dedicated classrooms and is mostly individual offices. The experiment was over the same amount of time on the same day at the first floor. Figure 3 shows multiple sensors that displayed inconsistent air temperatures (Sensor 7446 located on mid-room on a desk and Sensor 10694 located on mid-room, mid-height); this could be due to changing temperature on surface areas or to sensor's proximity to a vent where mechanical ventilation was still causing air movement.

The model and sensor temperatures did reflect a decrease in the air temperature, but the model showed that the temperature reached the mid-50s °F (mid-teens °C). The air temperature for the model data could indicate infiltration and heat loss through the spaces pitched roof system.

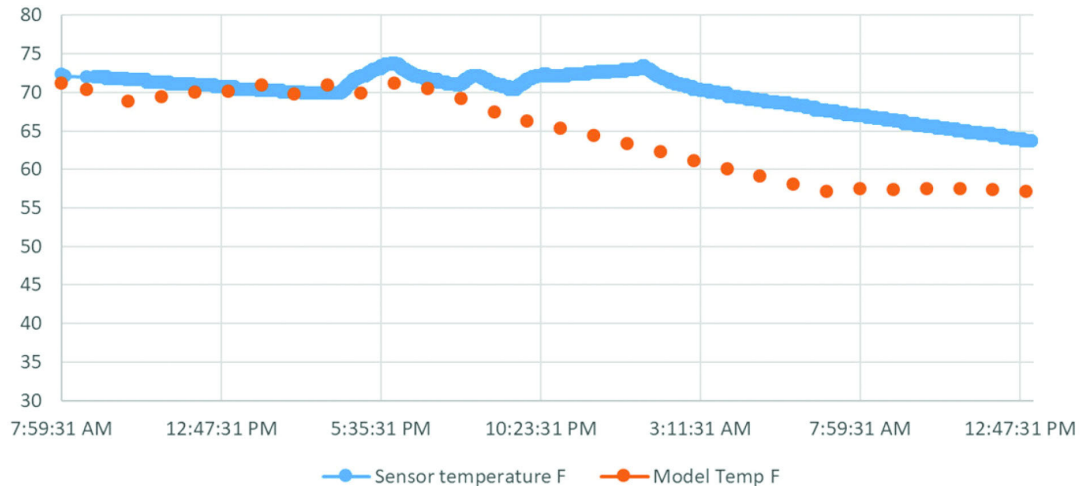
Figure 4 Bldg. 3013's heating failure results shown for 18 hours, where the sensor data is the solid line and the model data is the dotted line.

The data in Figure 4 shows good agreement with the model and the sensor data. From 8:00 a.m. to 5:00 p.m., the temperatures are very similar. During the evening, there seems to be a heat input to the building that is not in the model. But once the temperature decay starts, the slopes are very similar. Overall, you do not want

your model to underpredict the temperature decay; it is better to have the model predict that the building is getting colder sooner than the actual data. This way the prediction of when intervention is necessary happens before building damage occurs and will be a conservative estimate and more reliable to use.

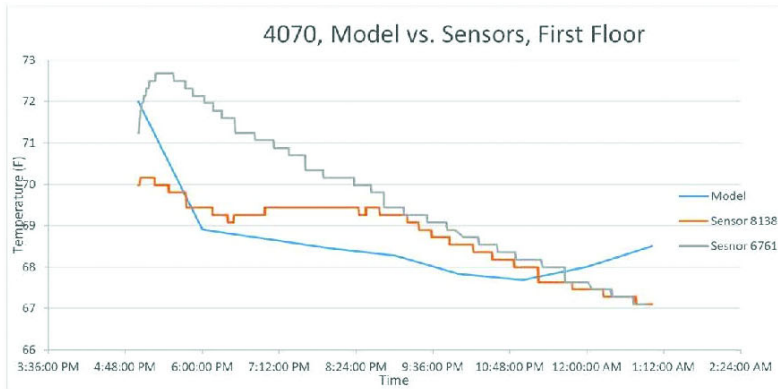
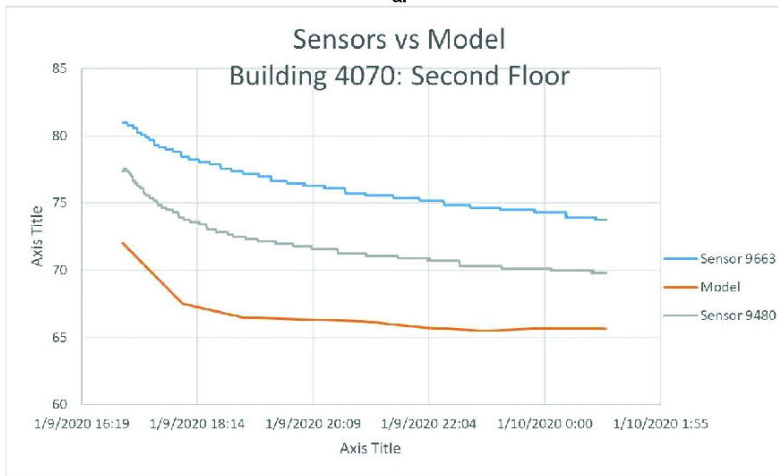
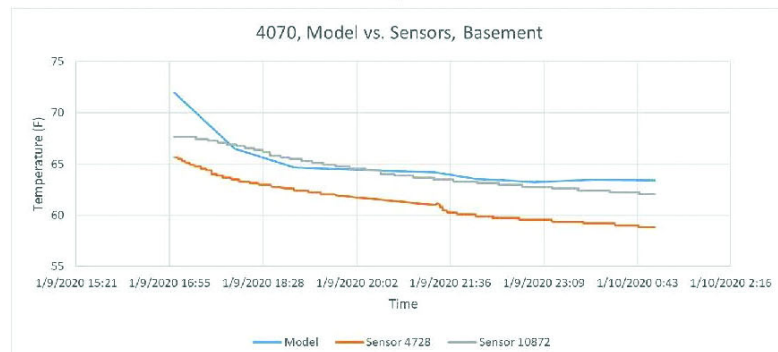
Figure 5 Bldg. 4070's (a) first floor, (b) second floor, and (c) basement heating failure results.

Both sensors reach a temperature minimum of 67.1°F (19.5°C) while the building model for the first floor reached a minimum or 67.7°F (19.8°C) in eight hours. It is noteworthy that, unlike the sensors, the model temperature begins to trend back upward. However, the increase accounted for only 1°F (0.56°C) of change across the trend. Sensor 8138 experiences a plateau that is not seen in the other sensor, and it can also be observed the most temperature decay seems to occur in the

The curves for each of the sensors as well as the model seem to follow the same general shape. What is most notable is the gap between each curve, or the starting point. In general, the sensor location in the actual facility had a warmer starting temperature than the model, with the model showing the set point at the thermostat. While the model began the decay at 72°F (22.2°C), Sensor 9480 began at 77°F (25.0°C) and Sensor 9663 at 81°F (27.2°C). Although there is a temperature gap between the model and the sensor data because the model never exceeds the actual temperature, it may still be useful in predicting resilience. The model shape shows the behavior of the building temperature decay is captured, while a real building will not be isotherm for all sensor locations. The temperature trend of the model would allow appropriate action to be taken as a prediction.

Basement. Once again, two sensors were selected to compare to the model data. Sensors 4728 and 10872 were each placed near interior walls atop shelves. Both sensors were approximately 4 ft (1.2 m) above the floor.

As with the second floor, the sensors show that this area is not isothermal, as expected. The model data seems to follow Sensor 10872 closely, with temperatures from the model being

slightly above those of the sensor. The model starts at a temperature of 72°F (22.2°C), while the sensors begin nearer to 66°F (18.9°C) at those sensor locations. The temperatures plotted on this zoomed-in scale show that the model follows the trend of the collected data well.

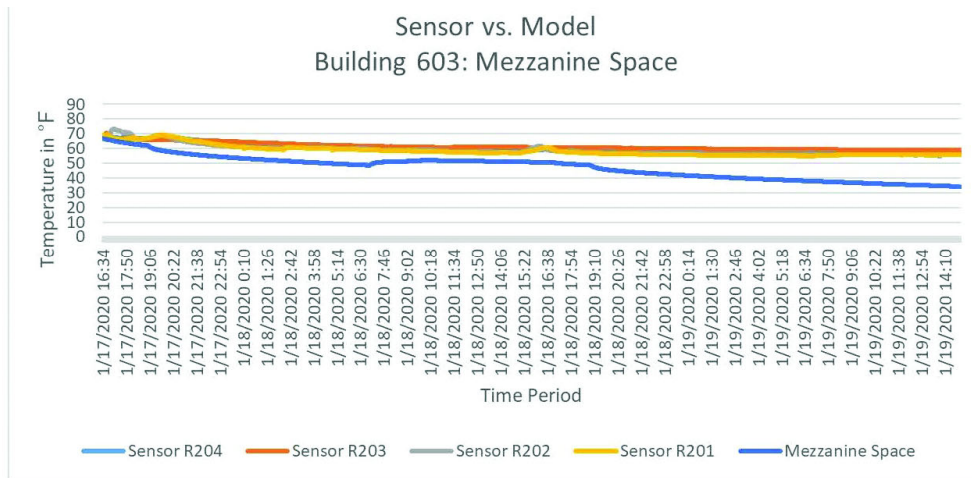
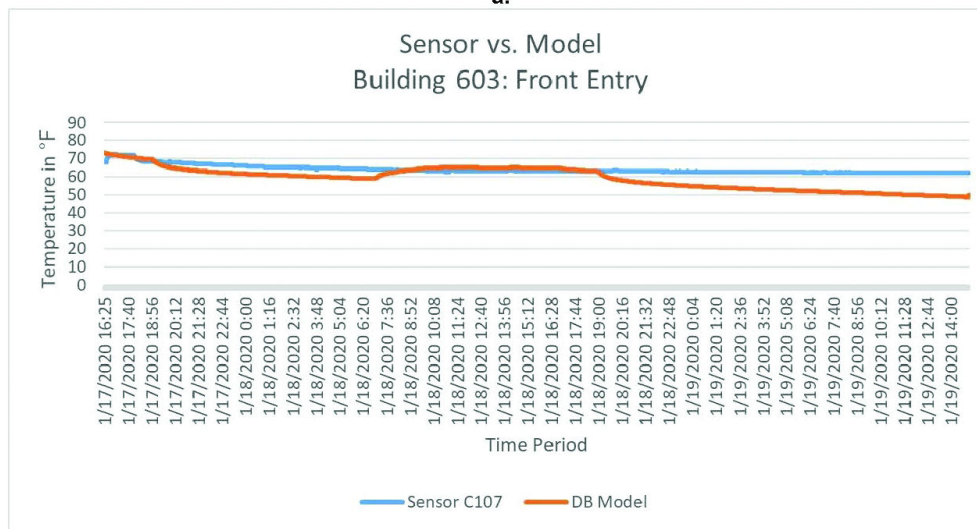
Figure 6 Air temperature details for Bldg. 603's (a) mezzanine and (b) front entry.

Figure 6 shows the comparison of Sensor 104 and the DesignBuilder simulation model in conditions that occurred after 19 hours of the heat failure experiment with ambient temperatures of -40°F (-40.0 °C). The initial temperature for the sensor data shows a temperature increase at the beginning of the experiment. The model data started with the interior temperature set point of 72°F (22.2°C) at 4:00 p.m. The sensor data compared to the model data indicates that the additional space of Bldg. 603 would react to the decay in the same fashion. The building decay would affect the space temperatures but not in the critical range for damage to the building. The time of recovery happens quickly for both cases.

air temperature in the space during the -40°F (-40.0 °C) outdoor air temperature, but the model indicates a greater decrease in air temperature over the time period. Air infiltration, the exterior wall, or the wind speed could be the reason for the difference between the model and the sensor data.

The front entry of Bldg. 603 faces west. The sensor and model data show declines in the air temperature once the heat failure experiment commences. The air temperatures are similar for both sensor and model, but the model indicates a rapid decline in air temperature, reaching the upper 40s degrees Fahrenheit (4.4+°C) temperatures. The model would suggest that heat restoration would have to be implemented within the first eight hours on January 19th.

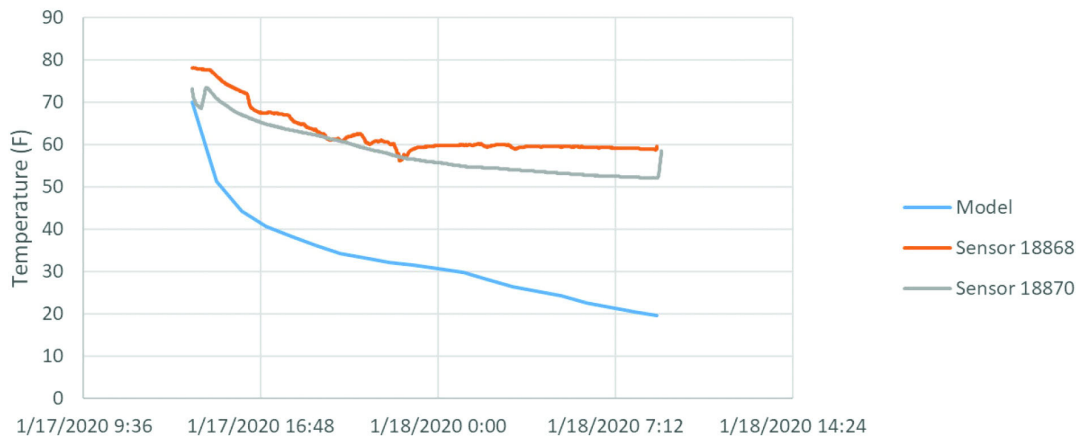
650 Model vs. Sensor Data

Figure 7 Model data versus sensor data for Bldg. 650.

The model in Figure 7 shows an almost immediate, sharp drop in building air temperature. Within the first two hours of

failure, the temperature falls to 30°F (−1.1°C). This would indicate that the building would be almost immediately inhabitable and damage to equipment would occur quickly as well.

A 19-hour thermal decay test was conducted for Bldg. 650 on January 18th and 19th, 2020. Two sensors were selected for comparison of the model data. The sensor data was compared to the average data for the entire facility. The test was conducted with outdoor temperatures near −40°F (−40.0 °C).

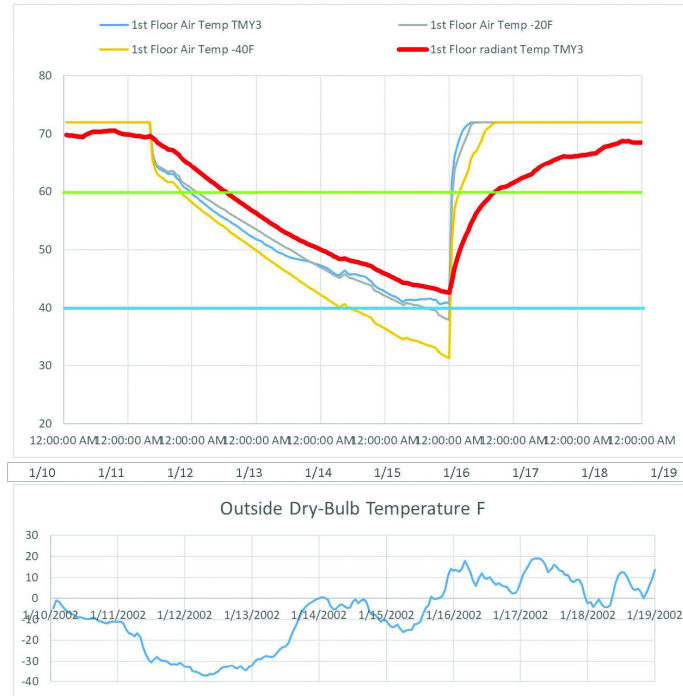
Figure 8 First floor (a) low efficiency and (b) high efficiency mass building heating failure results with TMY3, -20°F (-28.9°C) and -40°F (-40°C) weather from January 10th to 19th.

Figure 8a shows a mass building with lower efficiency envelope parameters and a normal TMY3 file and files with constant low temperatures, i.e., –20°F, –40°F (–28.9°C, –40.0°C). For comparison, the first floor radiant temperature with TMY3 weather is plotted to see the impact and time delay of the radiant temperature compared to the air temperature. In the graph below with the mass building, it lags the air both on the decay, especially during the recovery back to the set point. To keep the figure from being too cluttered, only one radiant temperature is plotted but the general behavior for the other two cases would be similar.

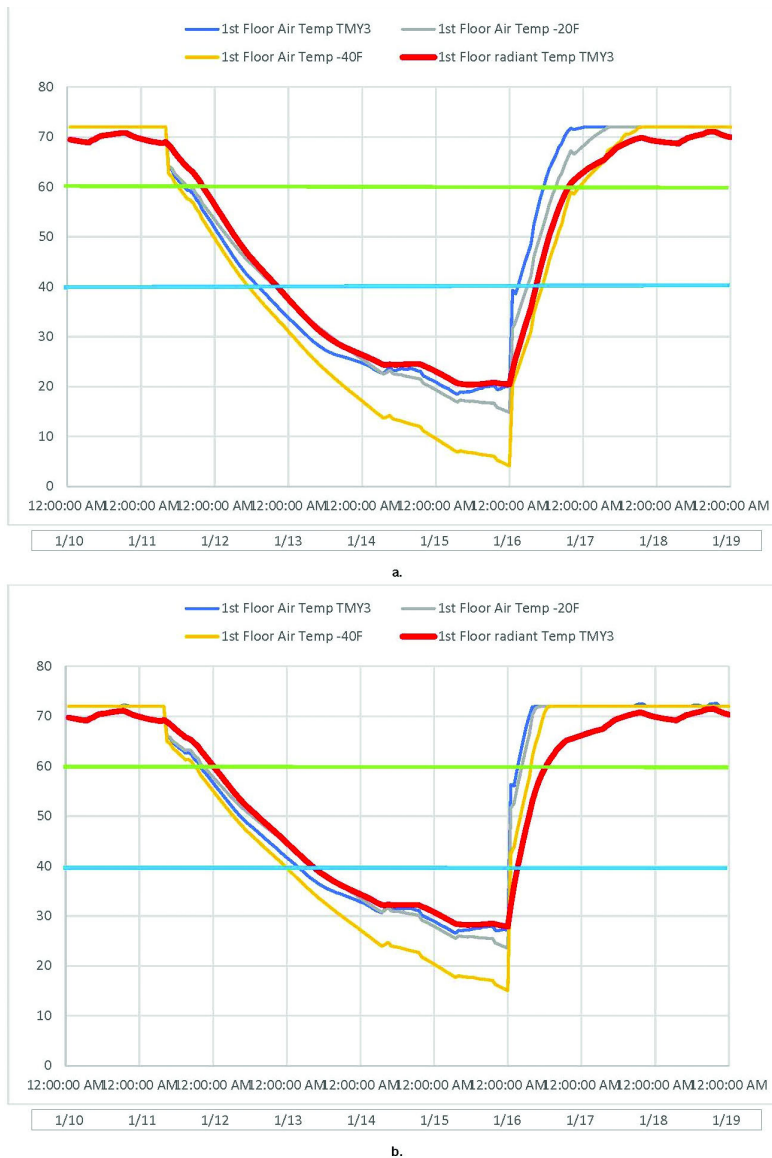
Figure 9 First floor (a) low efficiency and (b) high efficiency frame building heating failure results with TMY3, -20°F and -40°F (-28.9°C and -40.0°C) weather.

Figure 9a pertains to a frame building with lower efficiency envelope parameters and is shown with a normal TMY3 file and several files with constant low temperatures, i.e., –20°F, –40°F (–28.9°C, –40.0°C). It is also useful to compare the first floor radiant temperature with TMY3 weather to see the impact and time delay of the radiant temperature compared to the air temperature. In the graph below with the mass building, it lags the air both on the decay, especially during the recovery back to the set point.

Figure 9b is a frame building with high efficiency envelope parameters and is shown with a normal TMY3 file and several files with constant low temperatures, i.e., –20°F, –40°F (–28.9°C, –40.0°C). It is also useful to compare the first floor radiant temperature with TMY3 weather to see the impact and time delay of the radiant temperature compared to the air temperature. In the graph below with the mass building, it lags the air both on the decay, especially during the recovery back to the set point.

This low capacitance frame structure would reach the 40°F (4.4°C) threshold after about a day and a half in all cases. The higher efficiency envelope parameters allow for approximately a half day of additional time for response before damage starts to occur.

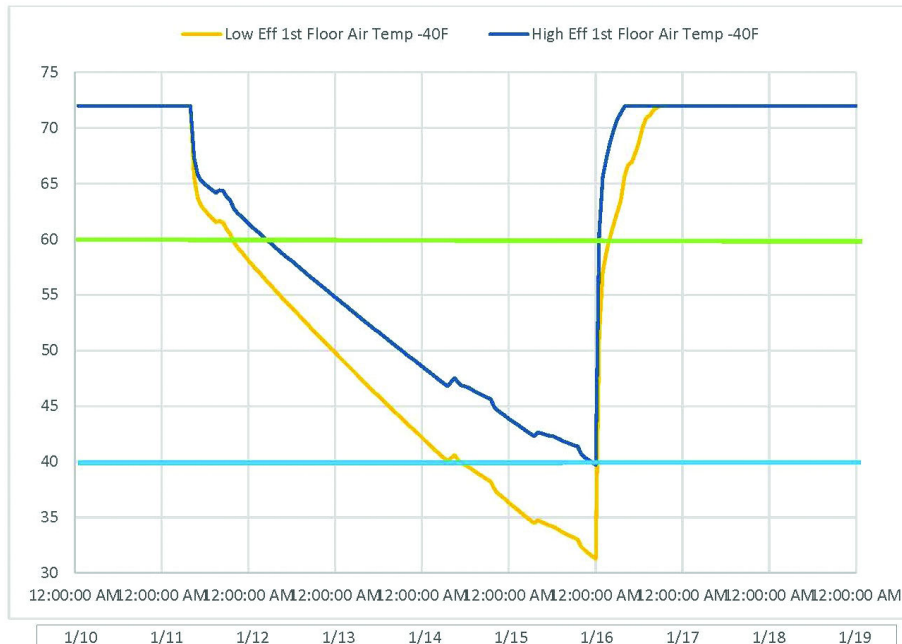
Figure 10 Mass building comparison of high efficiency, low efficiency, and typical 1980 parameters for building heating failure results with -40°F (-40.0°C) weather.

Figure 10 shows a cross-comparison of the mass building with constant –40°F (–40.0 °C) weather showing the air temperature from the high efficiency, lower efficiency, and

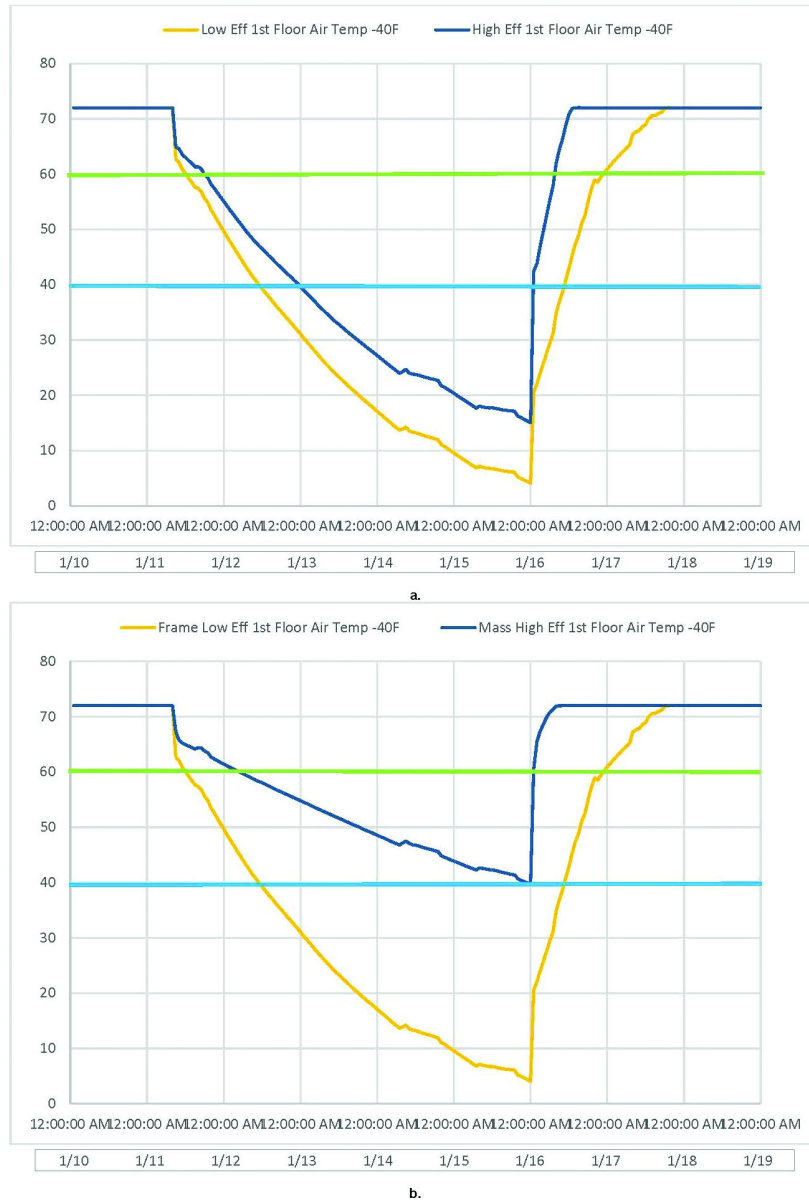
Figure 11 Comparison of a high efficiency versus a low efficiency and typical 1980 in building heating failure results at -40°F (-40.0°C) weather for a (a) frame building and a (b) mass building.

Figure 11a shows a cross-comparison of the frame building with -40°F (-40.0°C) weather, showing the air temperature from the high efficiency, lower efficiency, and typical

1980 envelope parameters. The frame efficient building envelope parameters maintain temperatures for an extra half of a day before the 40°F (4.4°C) threshold is crossed as compared to the lower efficiency parameters. In a five-day heating failure, both buildings would experience freeze damage. The typical 1980 parameters are included for reference to show how older building parameters would compare.

Figure 11b shows a comparison between the frame building low efficiency and the mass building with high-efficiency building envelope parameters using -40°F (-40.0°C) weather.

This shows the best performer and the worst performer directly to see how efficient and capacitive buildings perform in extreme weather conditions. The figure shows that the difference between one day and approximately five days of heating failure can affect the survivability of an emergency heating failure in an extreme arctic environment for each type of building. This information indicates that it would be appropriate to house critical missions in efficient and capacitive buildings.

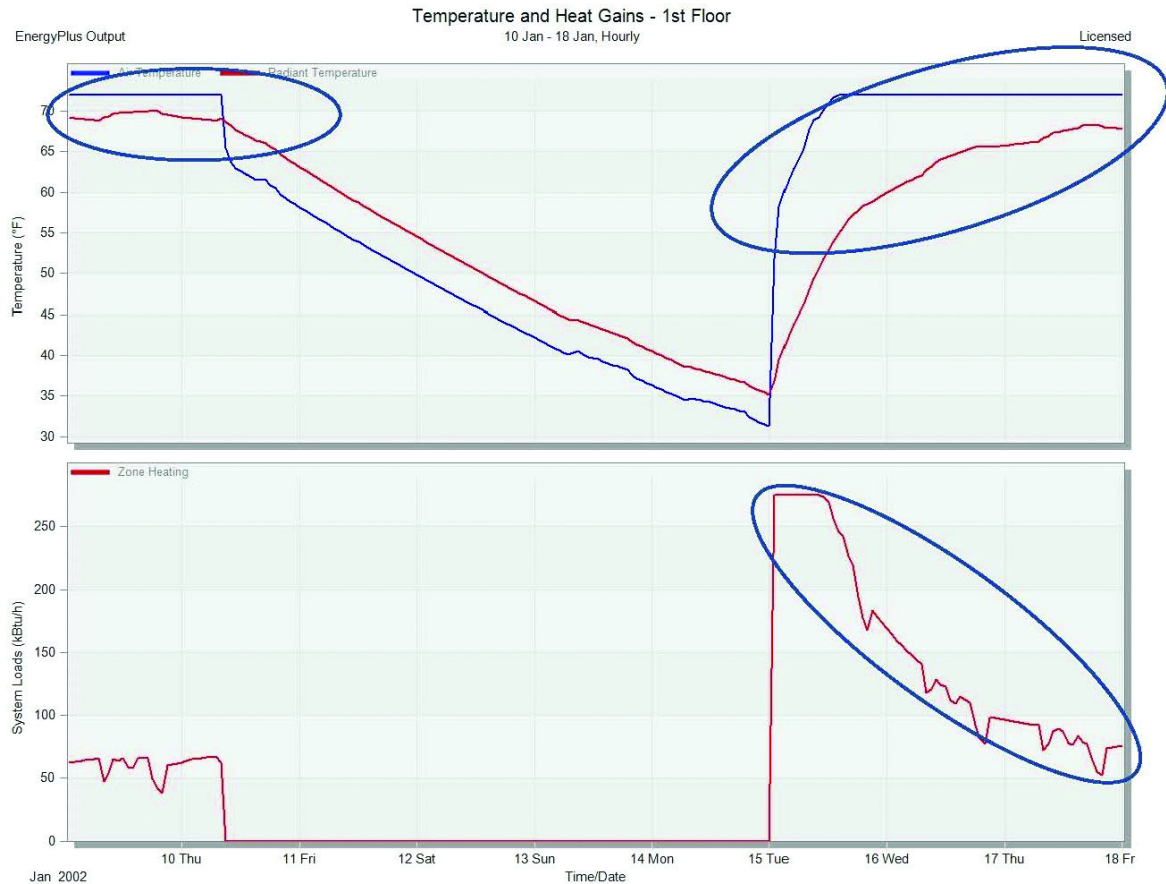
Figure 12 Heating failure results for Bldg. 4070 in -40°F (-40.0°C) weather.

Figure 12 shows the graphed results of a simulation run with a constant -40°F (-40.0°C) outdoor temperature for the mass building with lower-efficiency envelope parameters. Under normal operating conditions, the radiant temperature gives an indication of the surface temperatures in the zone, or

the windows, walls, ceiling, and floor. Prefailure for the mass building the radiant and air temperatures are very similar to the radiant temperature a couple of degrees below the air temperature. This difference is larger with the -40°F (-40°C) outdoor dry-bulb temperature (ODB) compared to an outdoor temperature of 0°F (-17.8°C). Therefore, the building capacitance would be considered charged.

During the failure, the air temperature crosses and falls lower than the radiant temperature as the air temperature leads the lagging radiant temperature. With a constant theoretical -40°F (-40.0°C) outdoor air temperature, there is a smooth temperature decay slope for both the air and the radiant temperatures. The air temperature reaches a minimum temperature of 31.3°F (-0.4°C) after five days. The

heating is restored, and the buildings start to recover. The heating was restored at midnight, and the air temperature reaches set point 12 to 13 hours later, around lunchtime for this building. However, note the lag of the radiant temperature on the upper temperature graph, which does not reach its prefailure state until after three days of heating.

The last part of the graph indicates how long recovery takes once the heating has been restored. In the mass building scenario shown in Figure 12, it takes about half a day to recover to the normal operating air temperature in the building, with more than three days needed to recharge the thermal capacitance. The rate of temperature decay, minimum temperature, and length of recovery are all significant aspects of the building's thermal resiliency with the more efficient and capacitive structure being more thermally resilient.
